## Annual Report for the Martis Valley Groundwater Basin

### Water Years 2018 and 2019

# **Martis Valley Groundwater Basin Annual Report Water Years 2018 and 2019**

Truckee Donner Public Utility District (TDPUD)

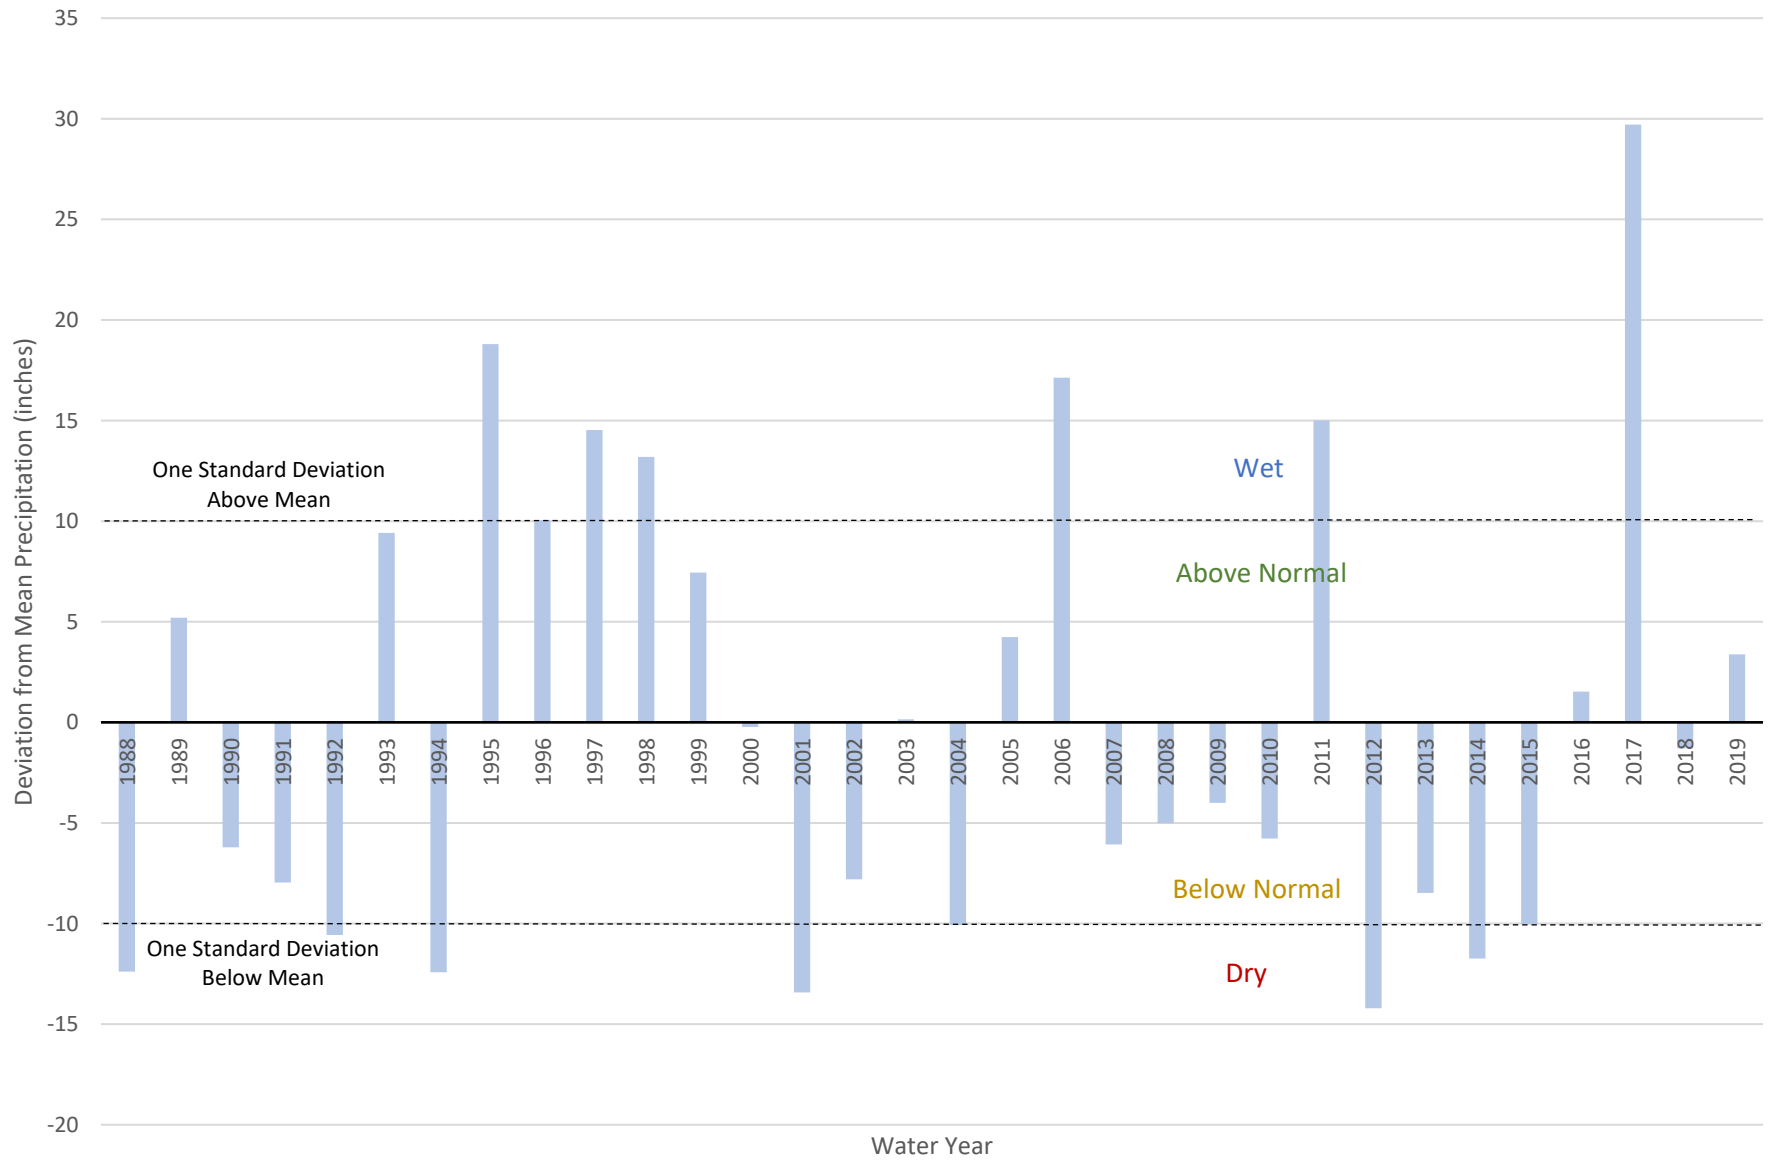
Figure 2  
Annual Precipitation Deviation from Mean: Truckee Ranger Station No. 049043

Water year types were developed for the MVGB using local precipitation data from Truckee Ranger Station No. 049043. Its location is shown on **Figure 1**. The deviation of annual WY precipitation from the mean is shown on **Figure 2**. Wet conditions were set at more than one standard deviation above the mean annual WY precipitation total. Above normal conditions were defined as annual precipitation between the mean value and one standard deviation above it. Likewise, below normal conditions were defined as an annual precipitation between the mean value and one standard deviation below it. Dry conditions were defined as an annual precipitation total more than one standard deviation below the mean. Water years 2018 and 2019 are classified as below normal and above normal water years, respectively. This corresponds with increases and decreases observed in both groundwater elevations over the same period.

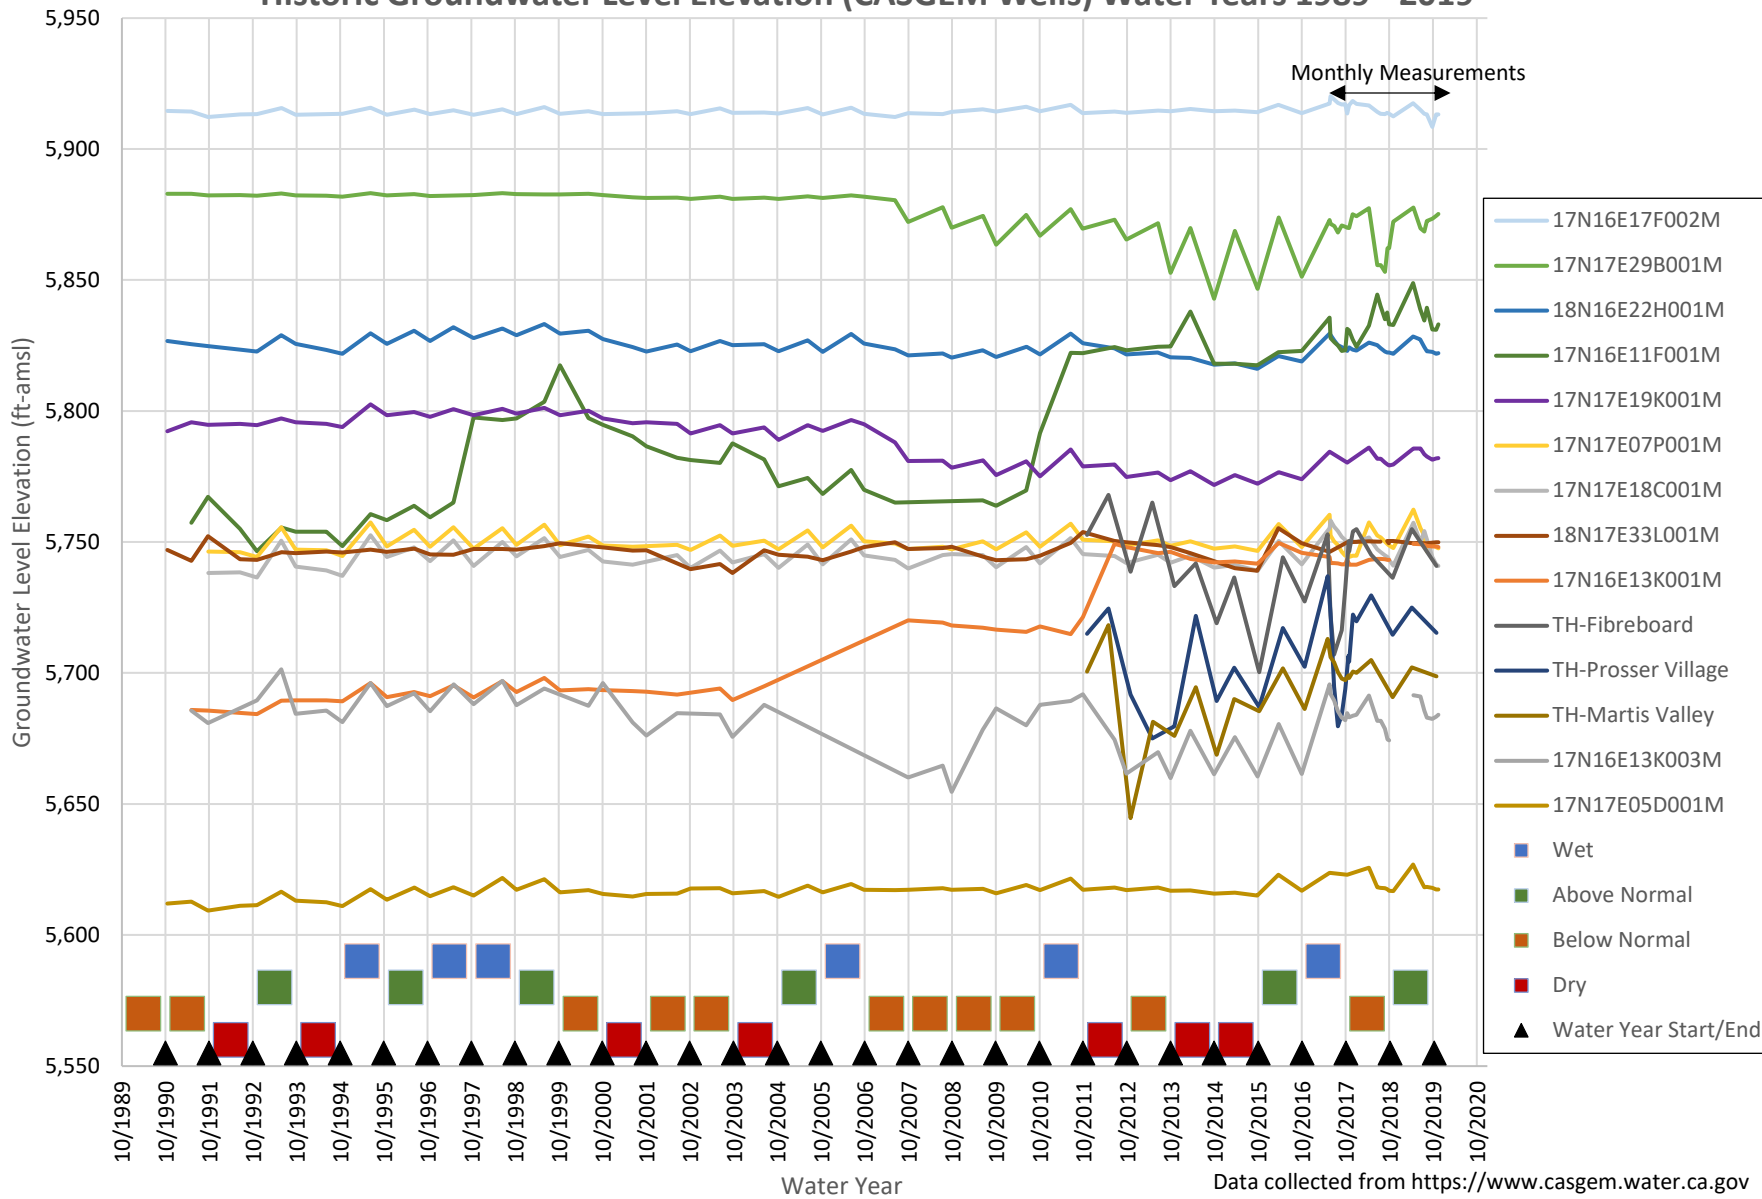
**Figure 4: Martis Valley Groundwater Basin**  
**Historic Groundwater Level Elevation (CASGEM Wells) Water Years 1989 - 2019**

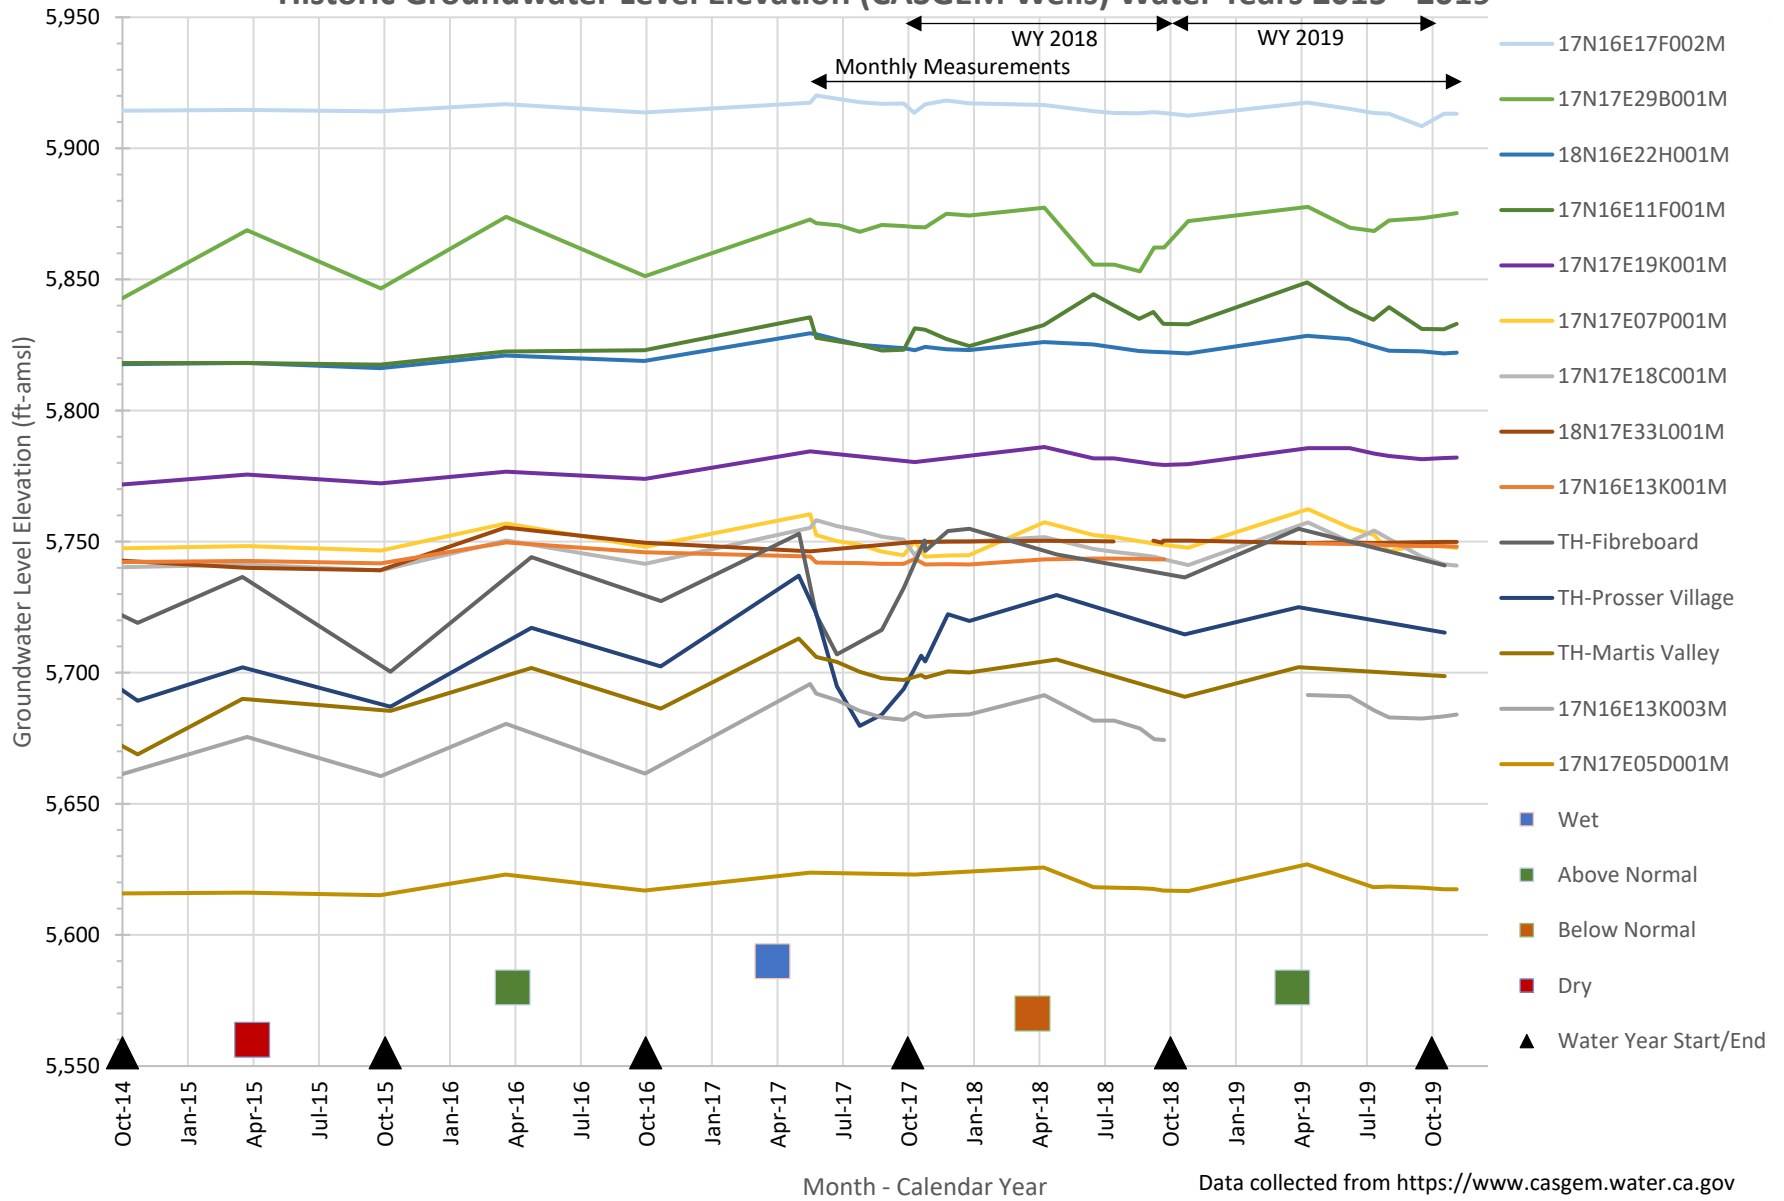
**Figure 5: Martis Valley Groundwater Basin**  
**Historic Groundwater Level Elevation (CASGEM Wells) Water Years 2015 - 2019**

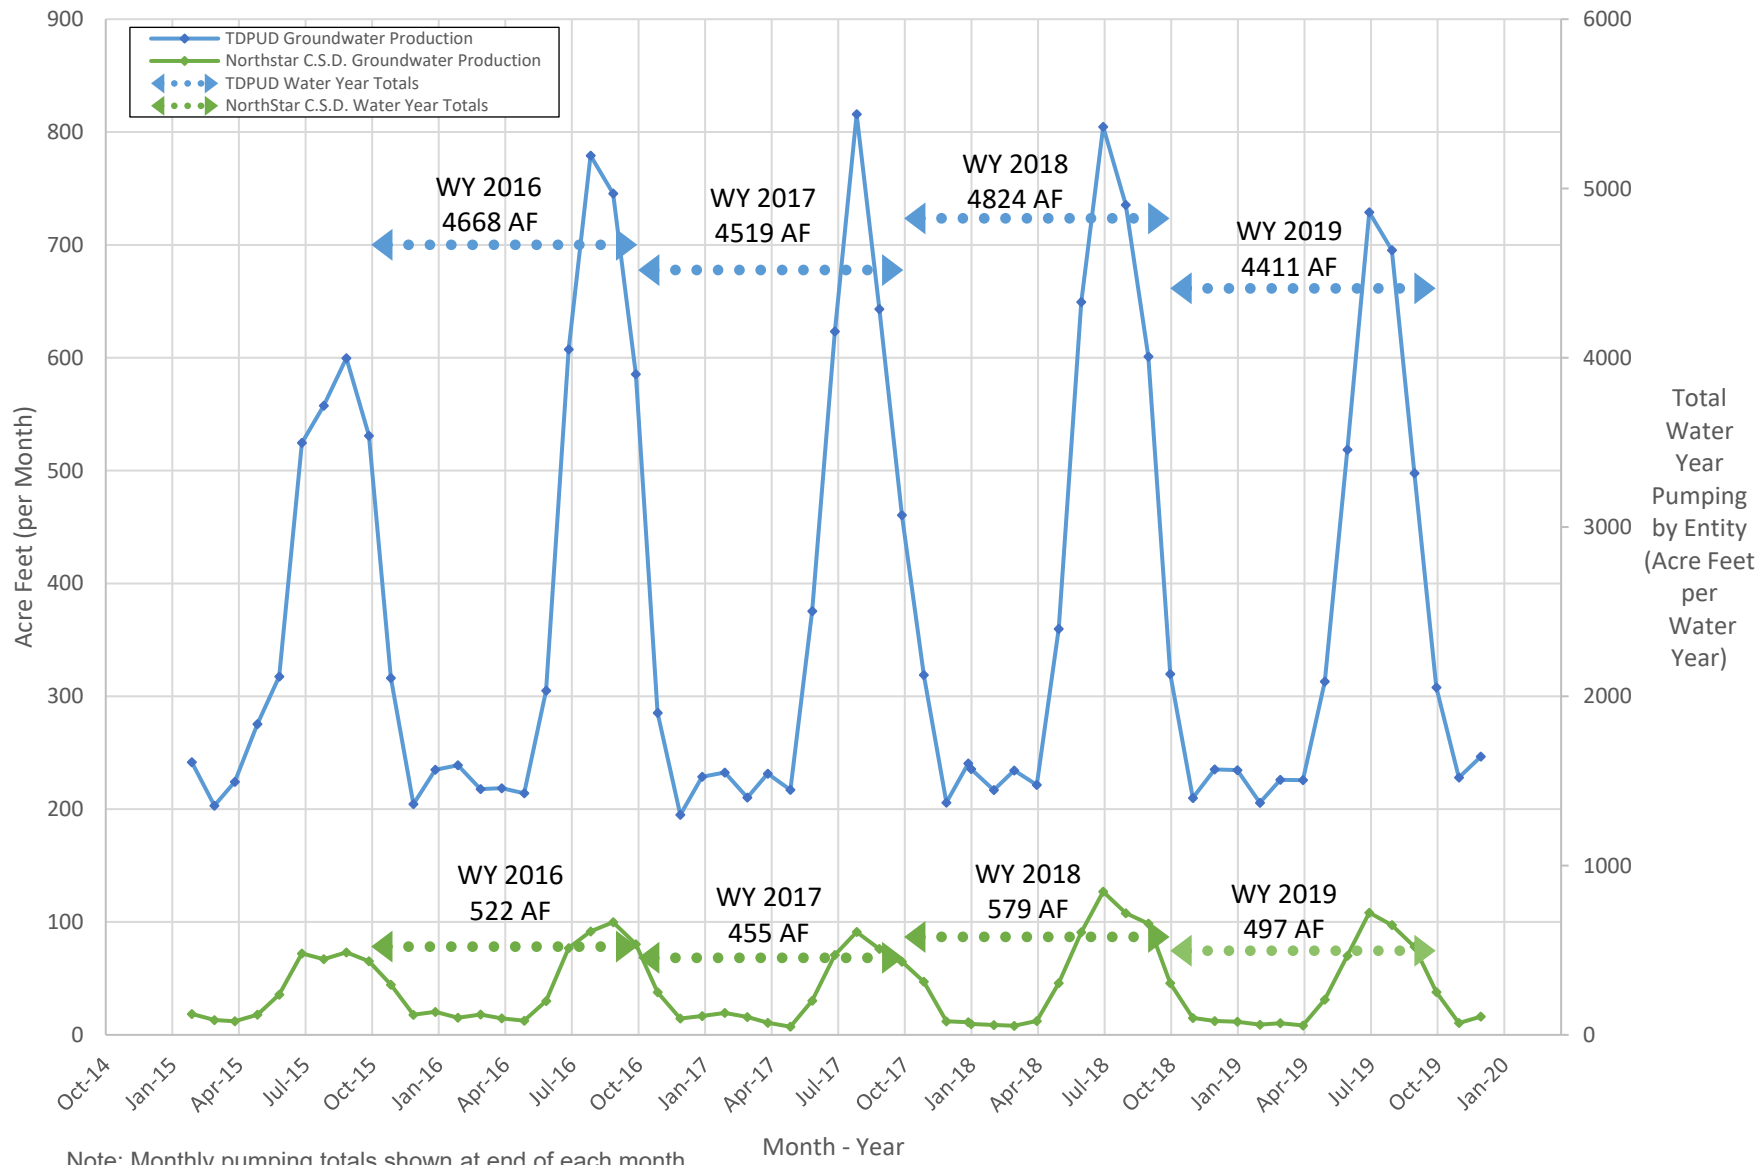
Figure 11  
Martis Valley Groundwater Basin Monthly Pump Totals

Note: Monthly pumping totals shown at end of each month.

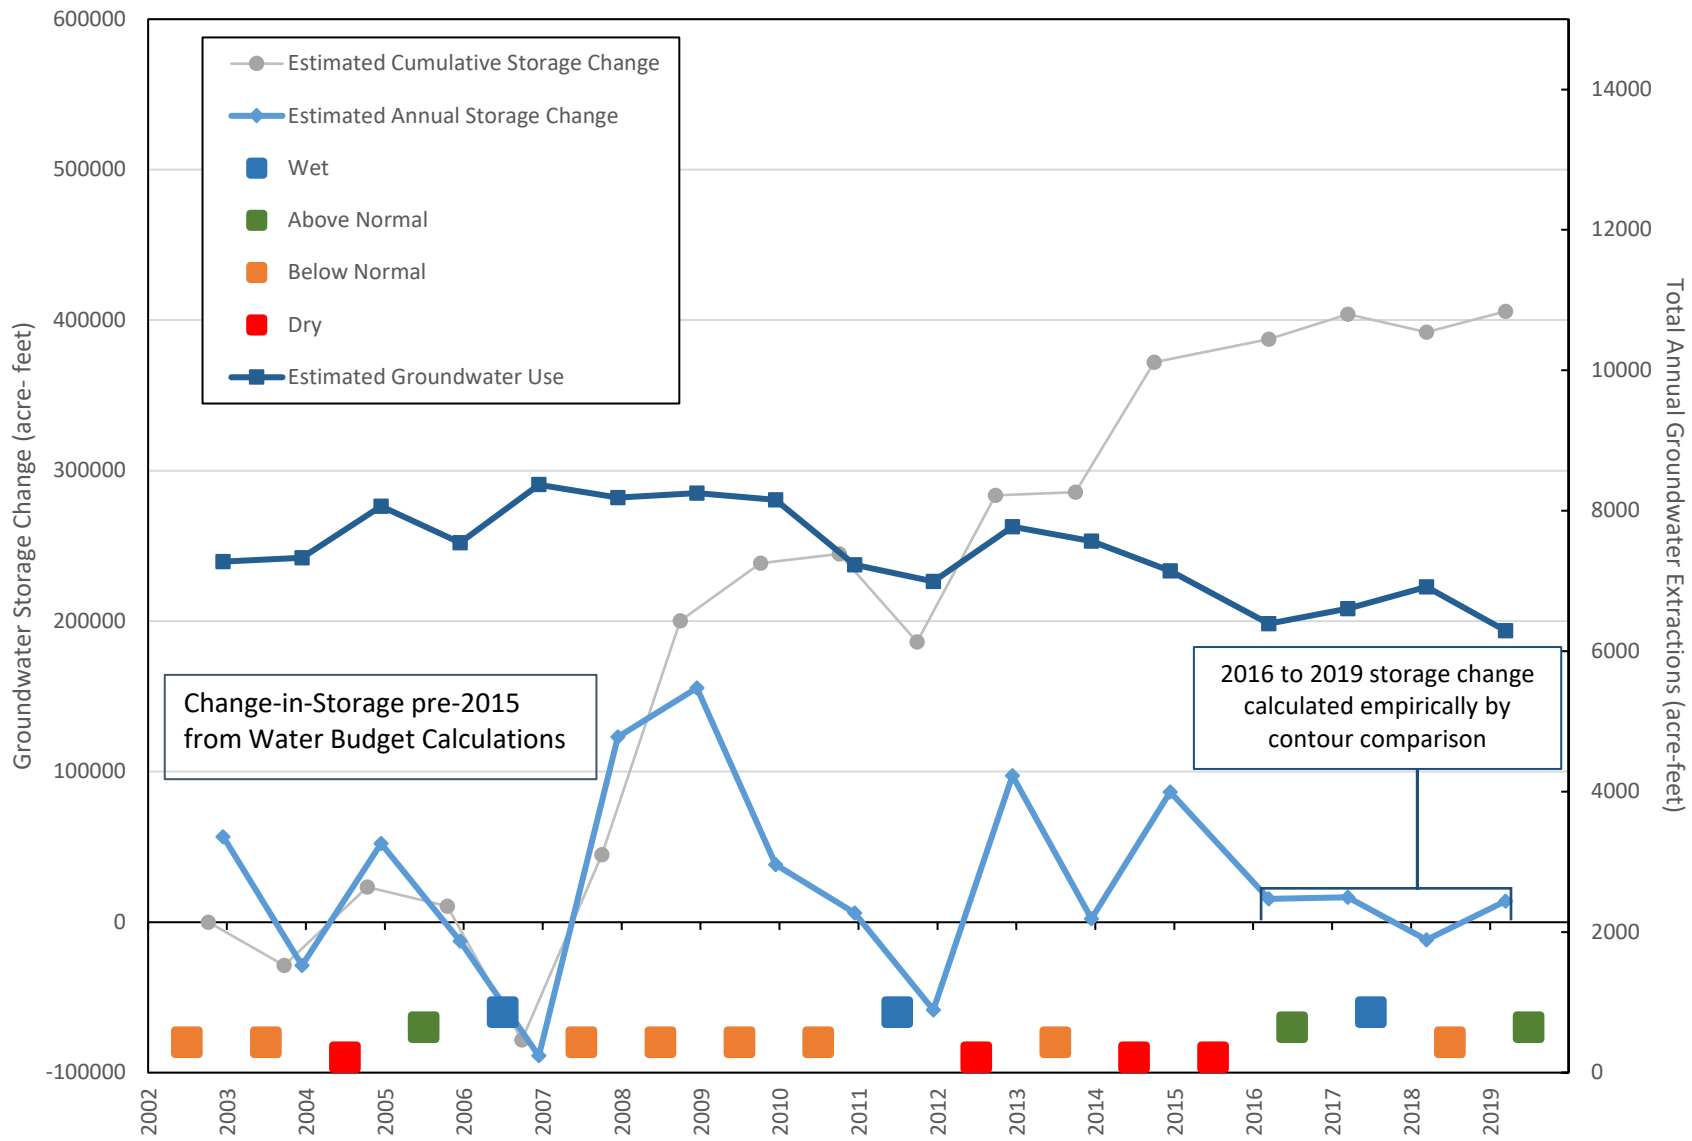
Figure 14  
Change in Storage and Groundwater Use

An empirical approach was used to calculate change in storage using spring groundwater elevation contours for 2017, 2018 and 2019. The spring contour surfaces were then subtracted to produce water level change distributions for the two previous water years. The use of spring to spring water level differences was deemed to be the most appropriate when assessing ambient groundwater conditions, because it has less influence of temporal, localized changes due to pumping adjacent to monitoring wells.

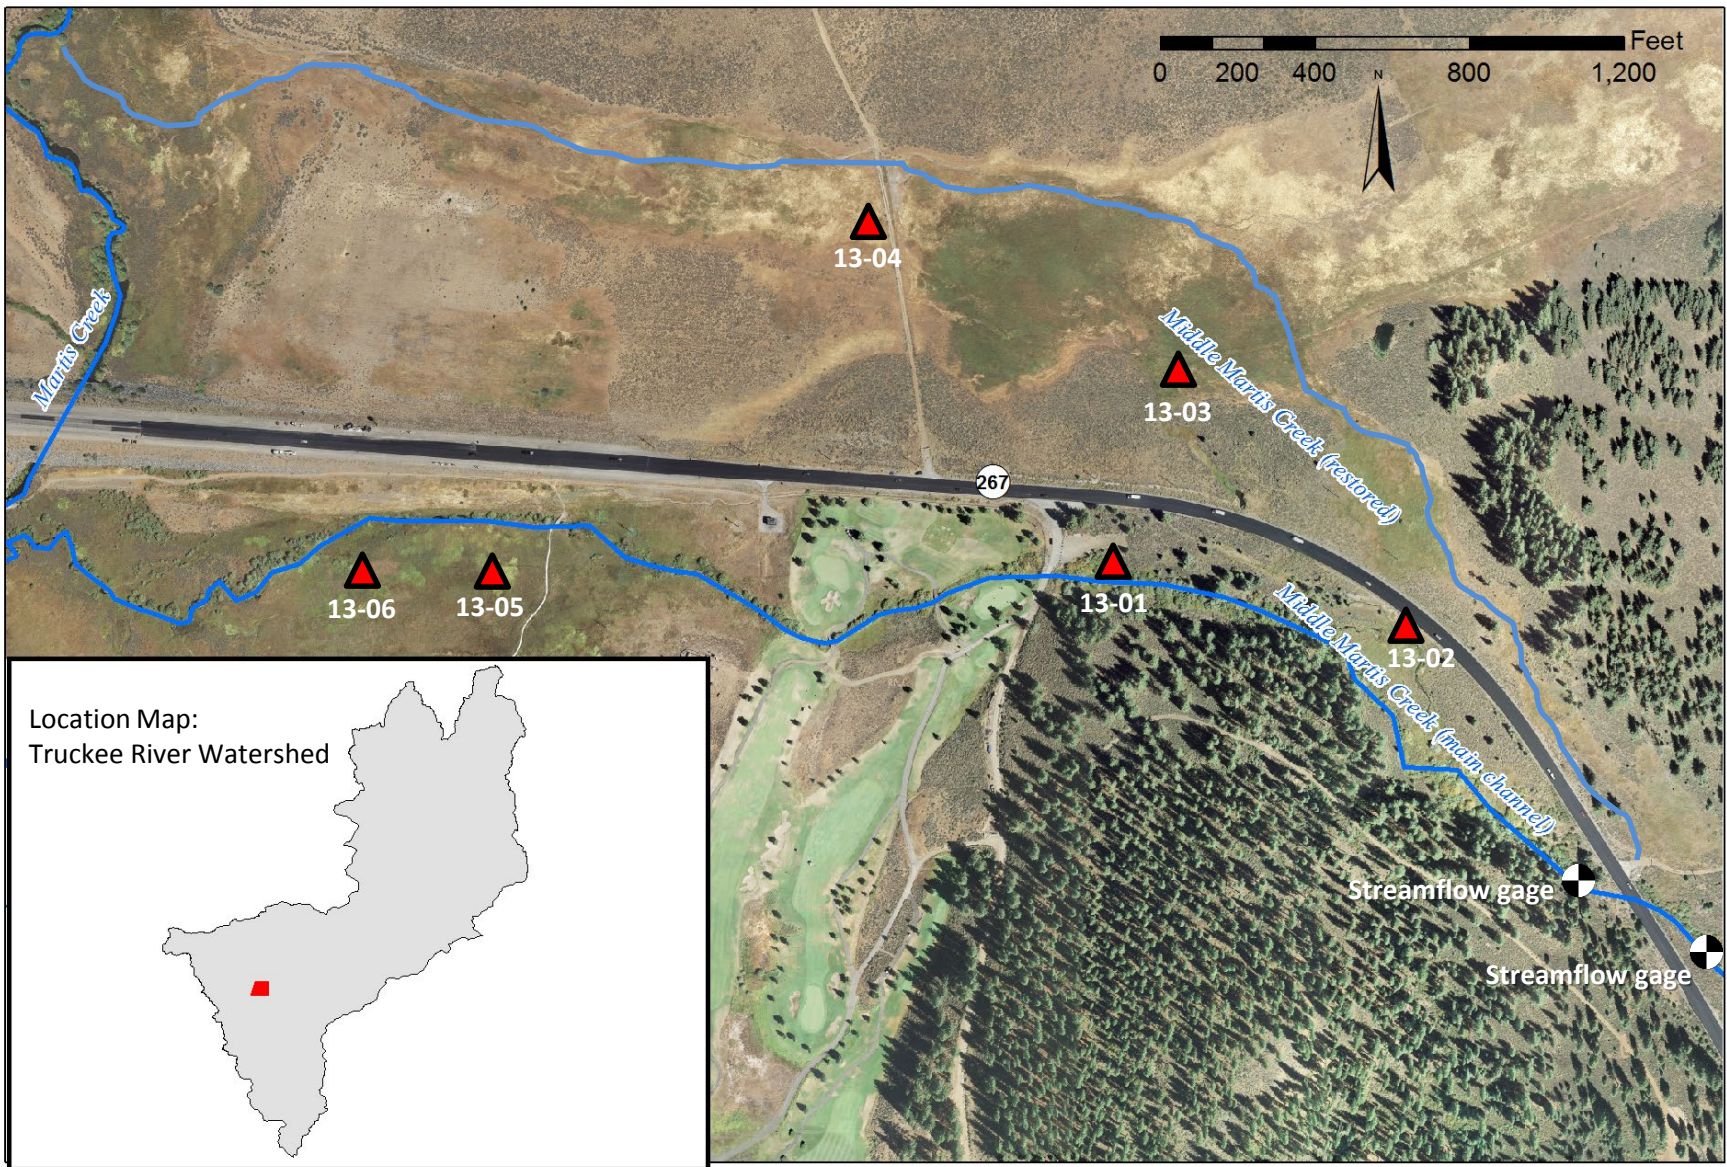
**Figure 1. Middle Martis Creek Wetland Restoration, Surface and Groundwater Monitoring Locations, Placer County, California. August 2017 aerial photograph (Post-Restoration)** Streamflow was restored to the historical channel in October 2016; baseflow is designed to continue down the main channel.

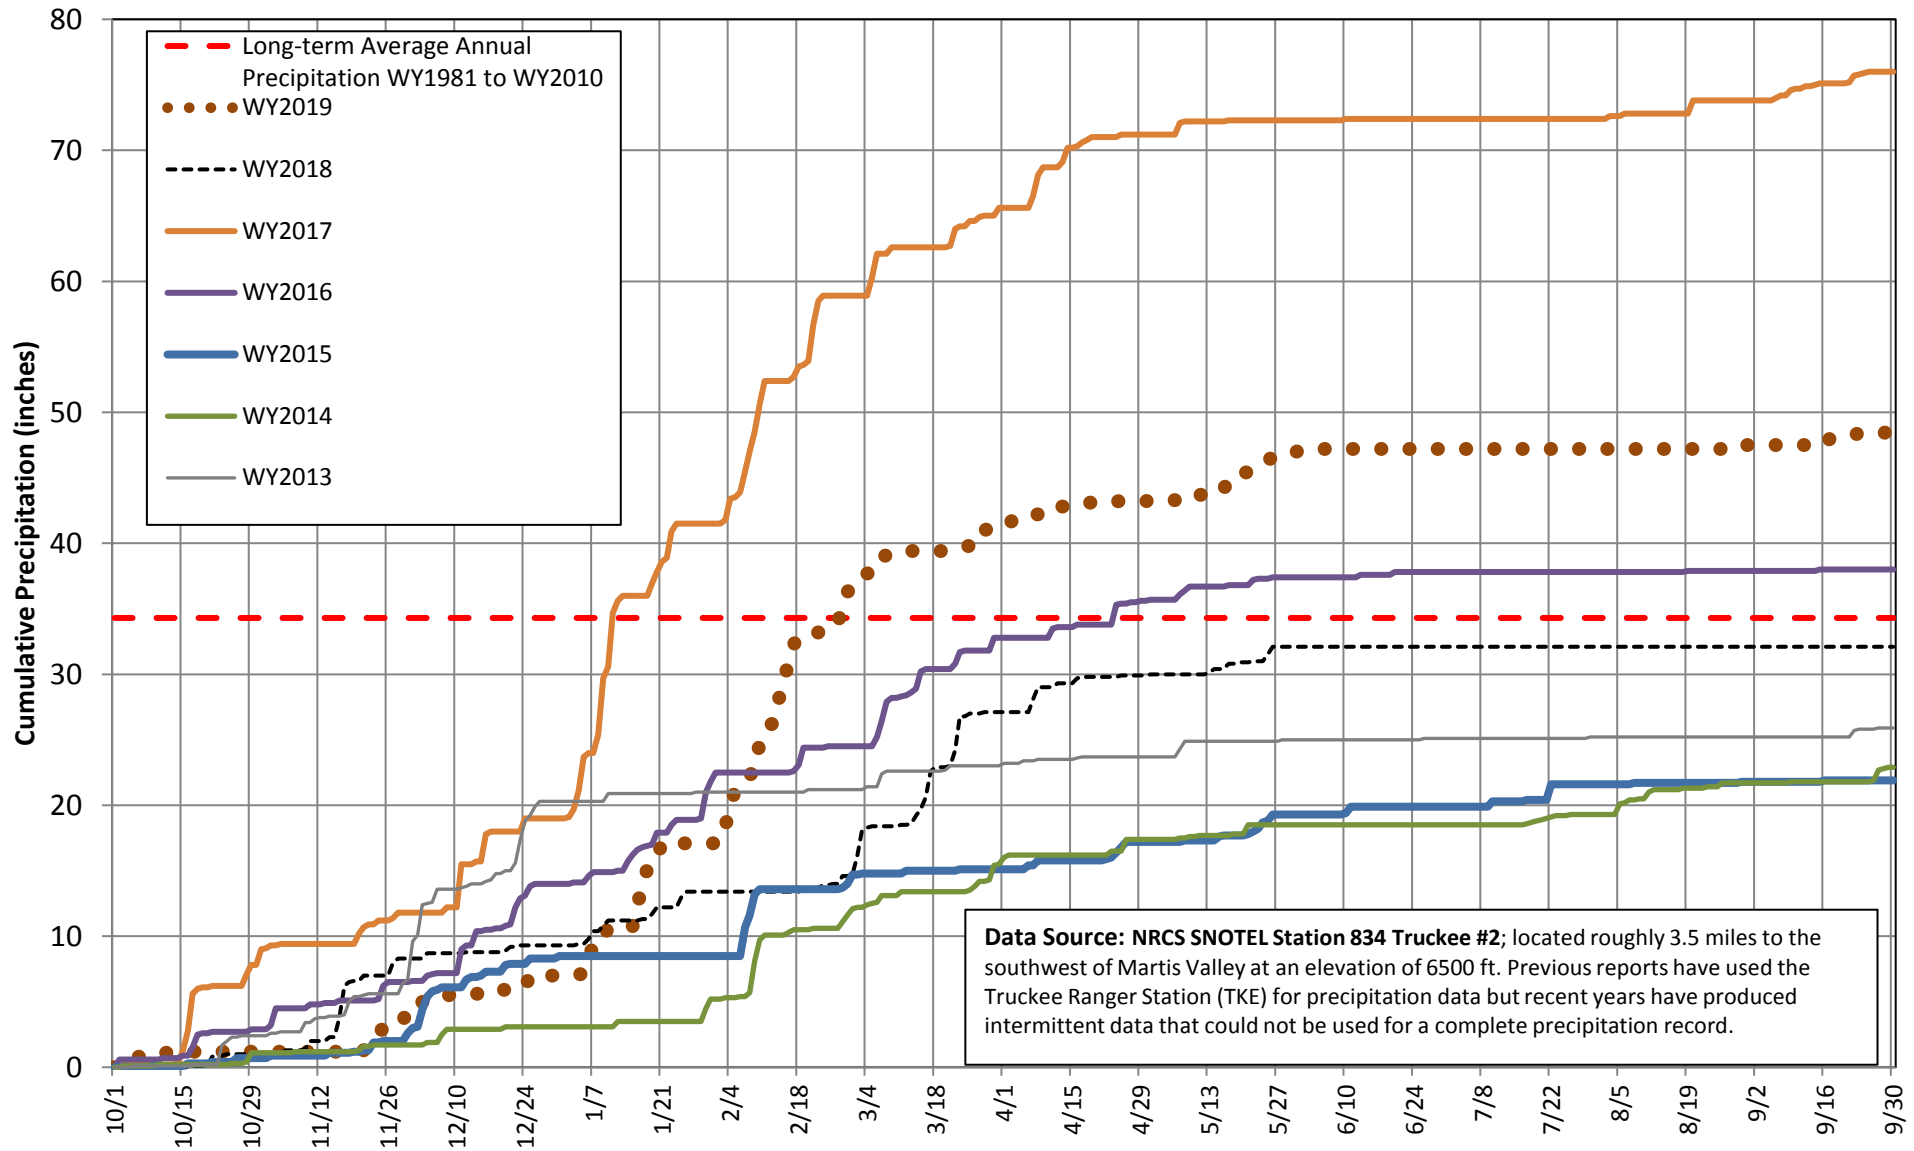
**Figure 2. Cumulative Daily Precipitation, Truckee, California, Water Years 2013-2019.** WY2019 annual precipitation was 48.7 inches, above the long-term (1980-2010) average annual precipitation of 34.3 inches.

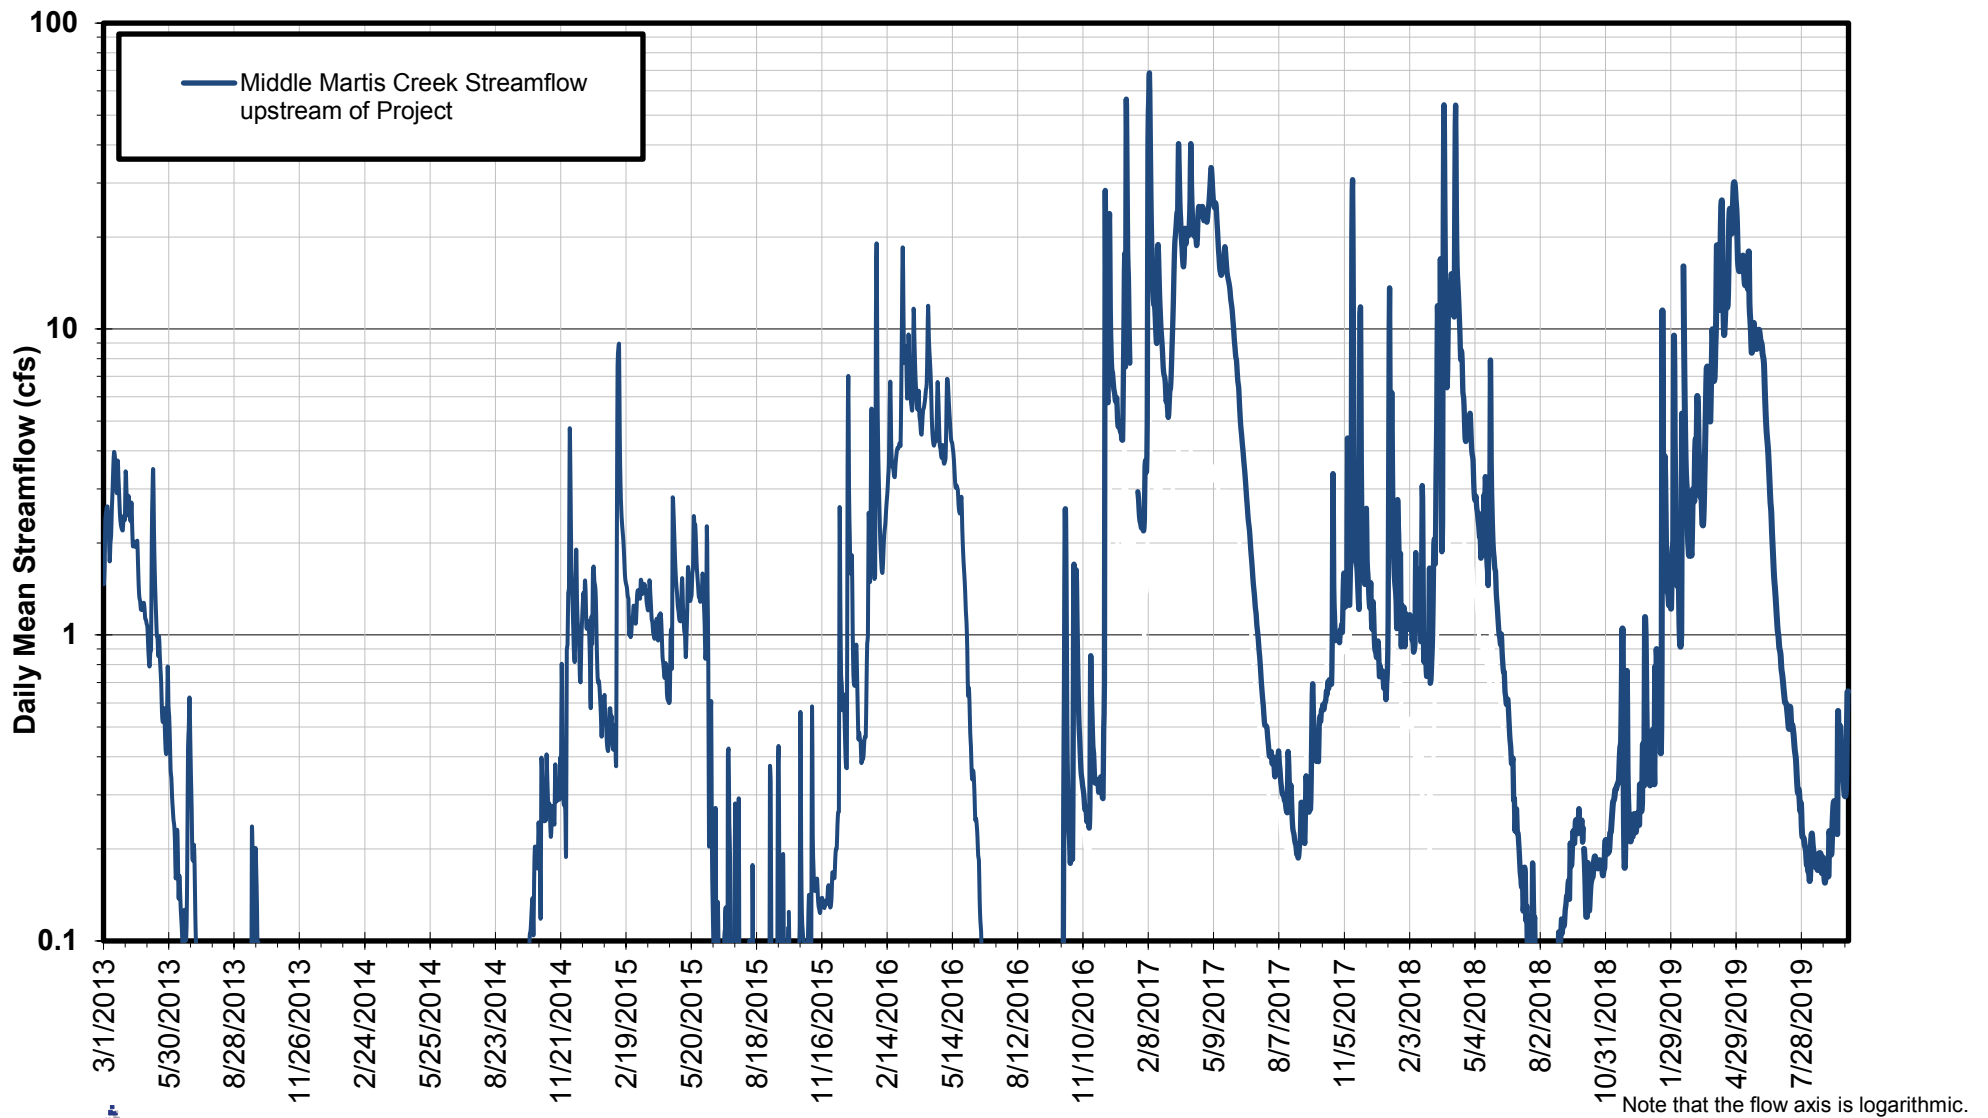
**Figure 3. Daily Mean Streamflow, Middle Martis Creek upstream of the Middle Martis Wetland Restoration Project, Placer County, California, WY2013 (partial) through WY2019.**

We characterize hydrology for the period of record to illustrate differences in streamflow as they relate to year type (i.e., dry, average, wet). We note that this streamflow gage is subject to freezing therefore, winter baseflow is sometimes estimated. In addition, our ability to measure streamflow less than 0.1 cfs is limited at this station. Low flows less than 0.1 cfs typically infiltrate the channel bed a short distance downstream of the gaging station and upstream of the restoration project.

In WY2013, peak snowmelt-runoff of 4.4 cfs occurred on March 14, 2013. Based on other nearby gages, annual peak flow was likely much higher and occurred on December 2, 2012, before the gaging station was installed. Subsequently, in late July and early August 2013, streamflow receded to roughly 0.02 cfs or less. Summer low flows infiltrated the streambed a short distance downstream of the gage, such that the channel was dry in the vicinity of the Project area. Partial annual runoff volume in WY2013 was estimated to be 359 acre-feet.

In WY2016, the annual peak flow of 30 cfs occurred on January 30, 2016 during a rain on snow event. An estimated peak snowmelt flow of 17 cfs occurred on April 9, 2016. Snowmelt runoff receded to baseflow conditions of less than 0.1 cfs by the end of June. Daily mean flows remained below 0.1 cfs for the rest of the water year (through September) due to a drier than average summer with no additional precipitation. Baseflow persisted further downstream in WY2016, but continuous flow downstream to the Project reach was not recorded even with near average annual precipitation. Annual runoff volume in WY2016 was calculated to be 1,416 acre-feet.

In WY2017, early autumn rain caused streamflow to increase in Middle Martis Creek during completion of the restoration project. Rain-on-snow events in December, January, February and March generated multiple peak flows that exceeded 50 cfs. The estimated annual peak flow of 84 cfs was recorded on February 9, 2017, also estimated to be the peak flow of record. The above-average snowpack resulted in a prolonged snowmelt runoff period with peak snowmelt runoff of approximately 40 cfs occurring on May 5, 2017. The snowmelt runoff receded into the summer months, but summer baseflow remained above 0.2 cfs for the first time during the period of record. Annual runoff volume in WY2017 was estimated to be 5,851 acre-feet.

In early WY2018, baseflow and runoff response was higher than in previous years due to the previous very wet year; autumn rain generated two peak flows greater than 10 cfs in November. Rain-on-snow events in January, March and April generated multiple additional peak flows. The annual peak flow of 54 cfs was measured on April 7, 2018. Near-record monthly snowfall in March 2018 allowed for snowmelt runoff to persist into the late spring, and baseflow receded into the summer months with flows receding to below 0.1 cfs in mid-July and dry conditions at our gage observed in August, likely the result of several months absent of precipitation. Baseflow increased in late August and September as a result of lower temperatures and reduced evapo-transpiration. Annual runoff volume in WY2018 was estimated to be 1,368 acre-feet; similar to WY2016.

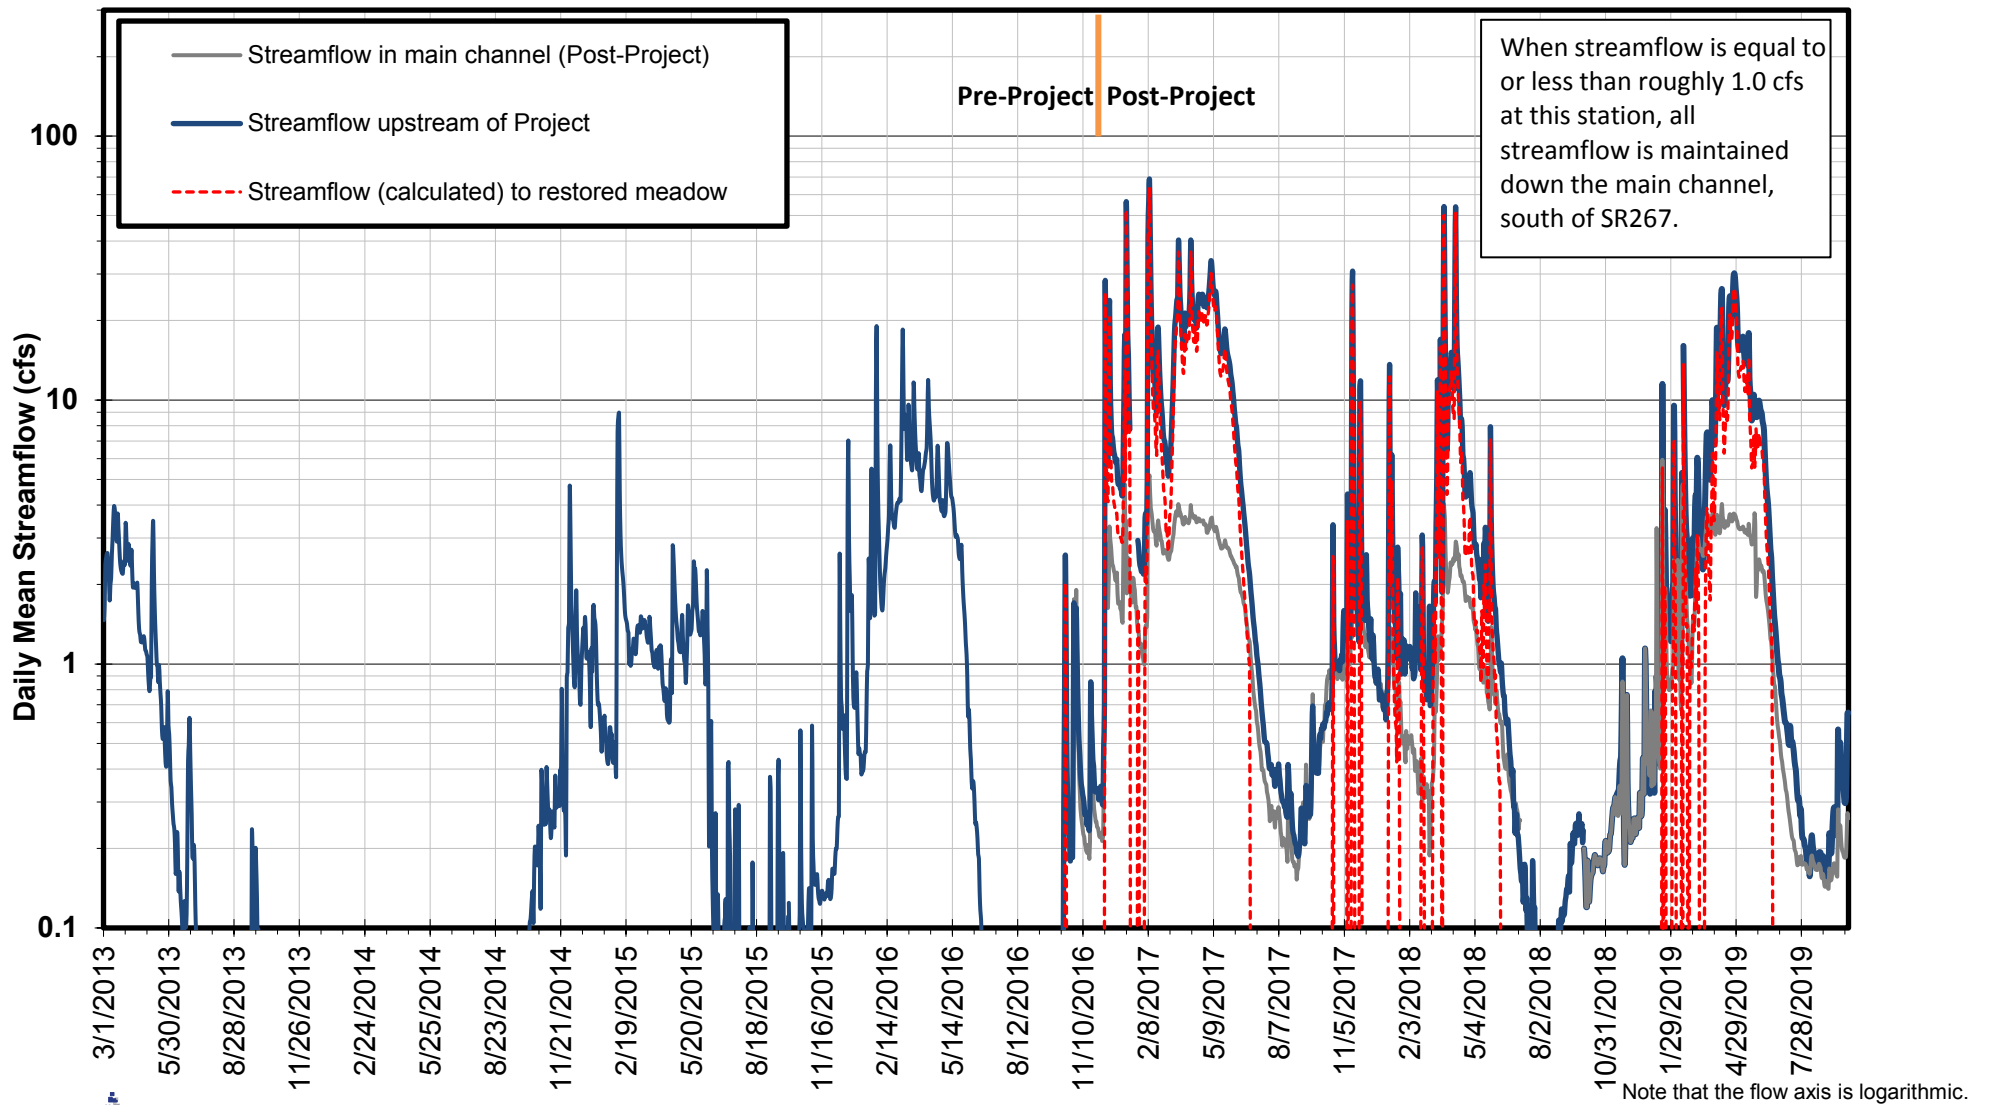
**Figure 4. Daily Mean Streamflow and Calculated Streamflow to Restored Reach and Meadow, Middle Martis Wetland Restoration Project, Placer County, California, WY2013 (partial) through WY2019.**

Returning peak flows and associated runoff volumes to the north side of SR 267 has reduced, and possibly, eliminated flooding that historically used to occur along the southside of the highway and near the main channel. In fact, higher peak flows were measured post-project when compared to pre-project and flooding was not observed on SR 267.

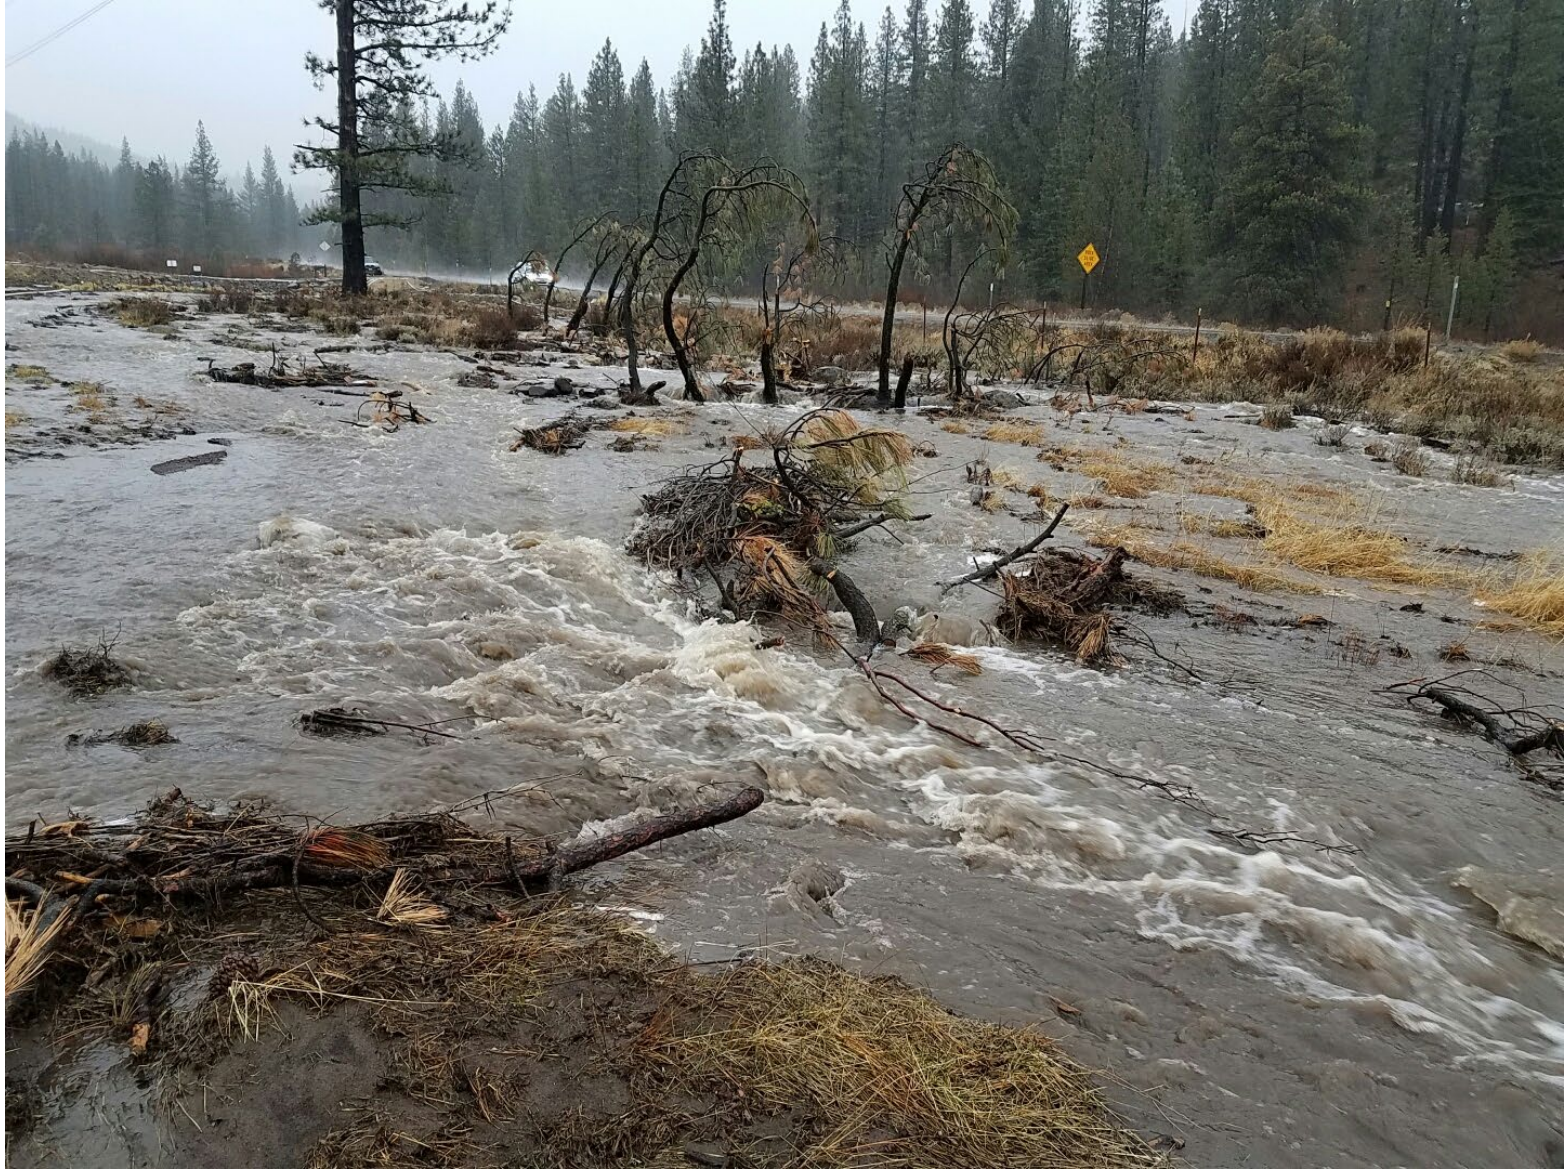
**Figure 5. Restored alluvial fan flooding, Middle Martis Restoration Project, Placer County, California.** December 10, 2016; flow in photo is calculated to be 40 cfs based on gaging records.
