## Annual Report for the Martis Valley Groundwater Basin

### Water Years 2018 and 2019

# **Martis Valley Groundwater Basin Annual Report Water Years 2018 and 2019**

Truckee Donner Public Utility District (TDPUD)

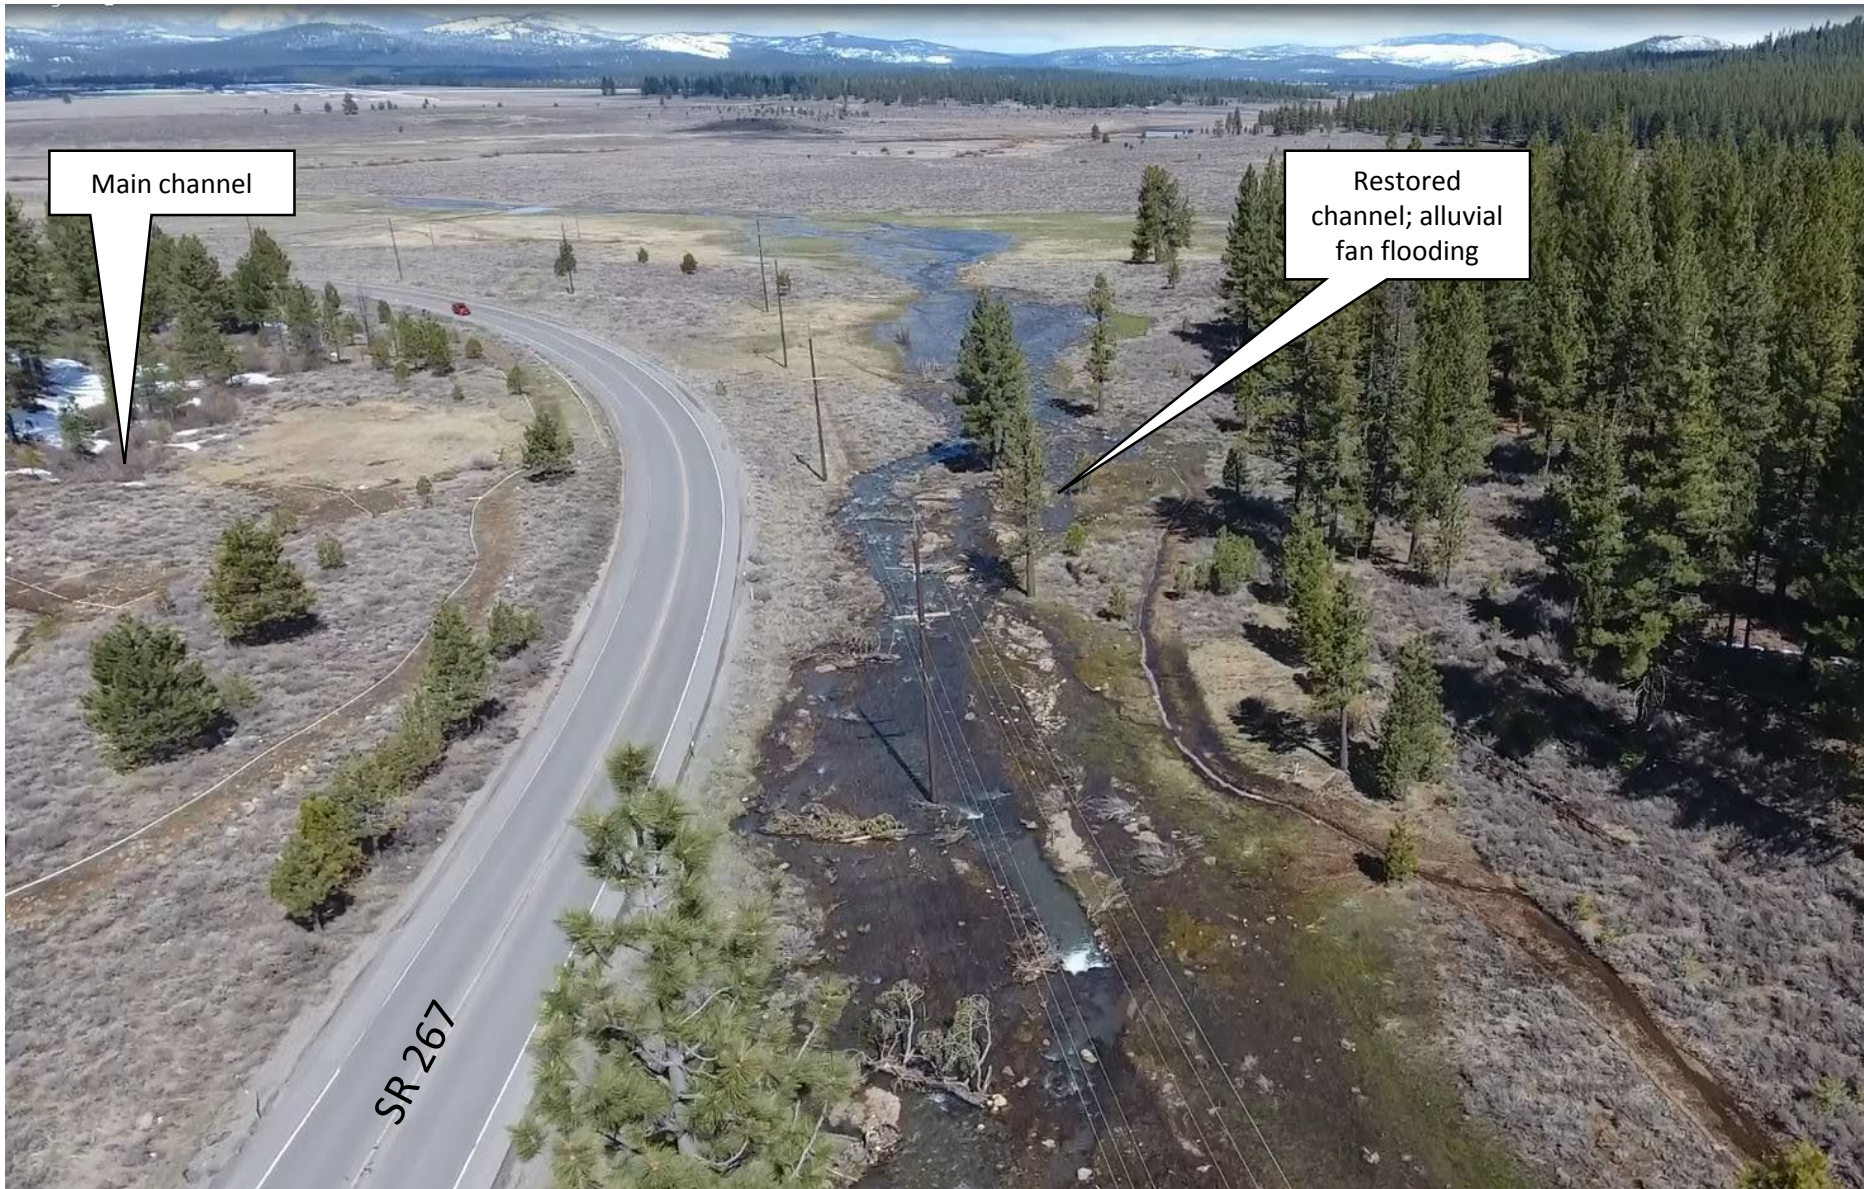
**Figure 6. Restored alluvial fan flooding, Middle Martis Wetland Restoration Project, Placer County, California.** Looking downstream; main channel identified on the left; restored channel and alluvial fan flooding center; near peak snowmelt runoff, April 17, 2017; flow to restored channel/meadow is calculated to be 25 cfs based on gaging records.

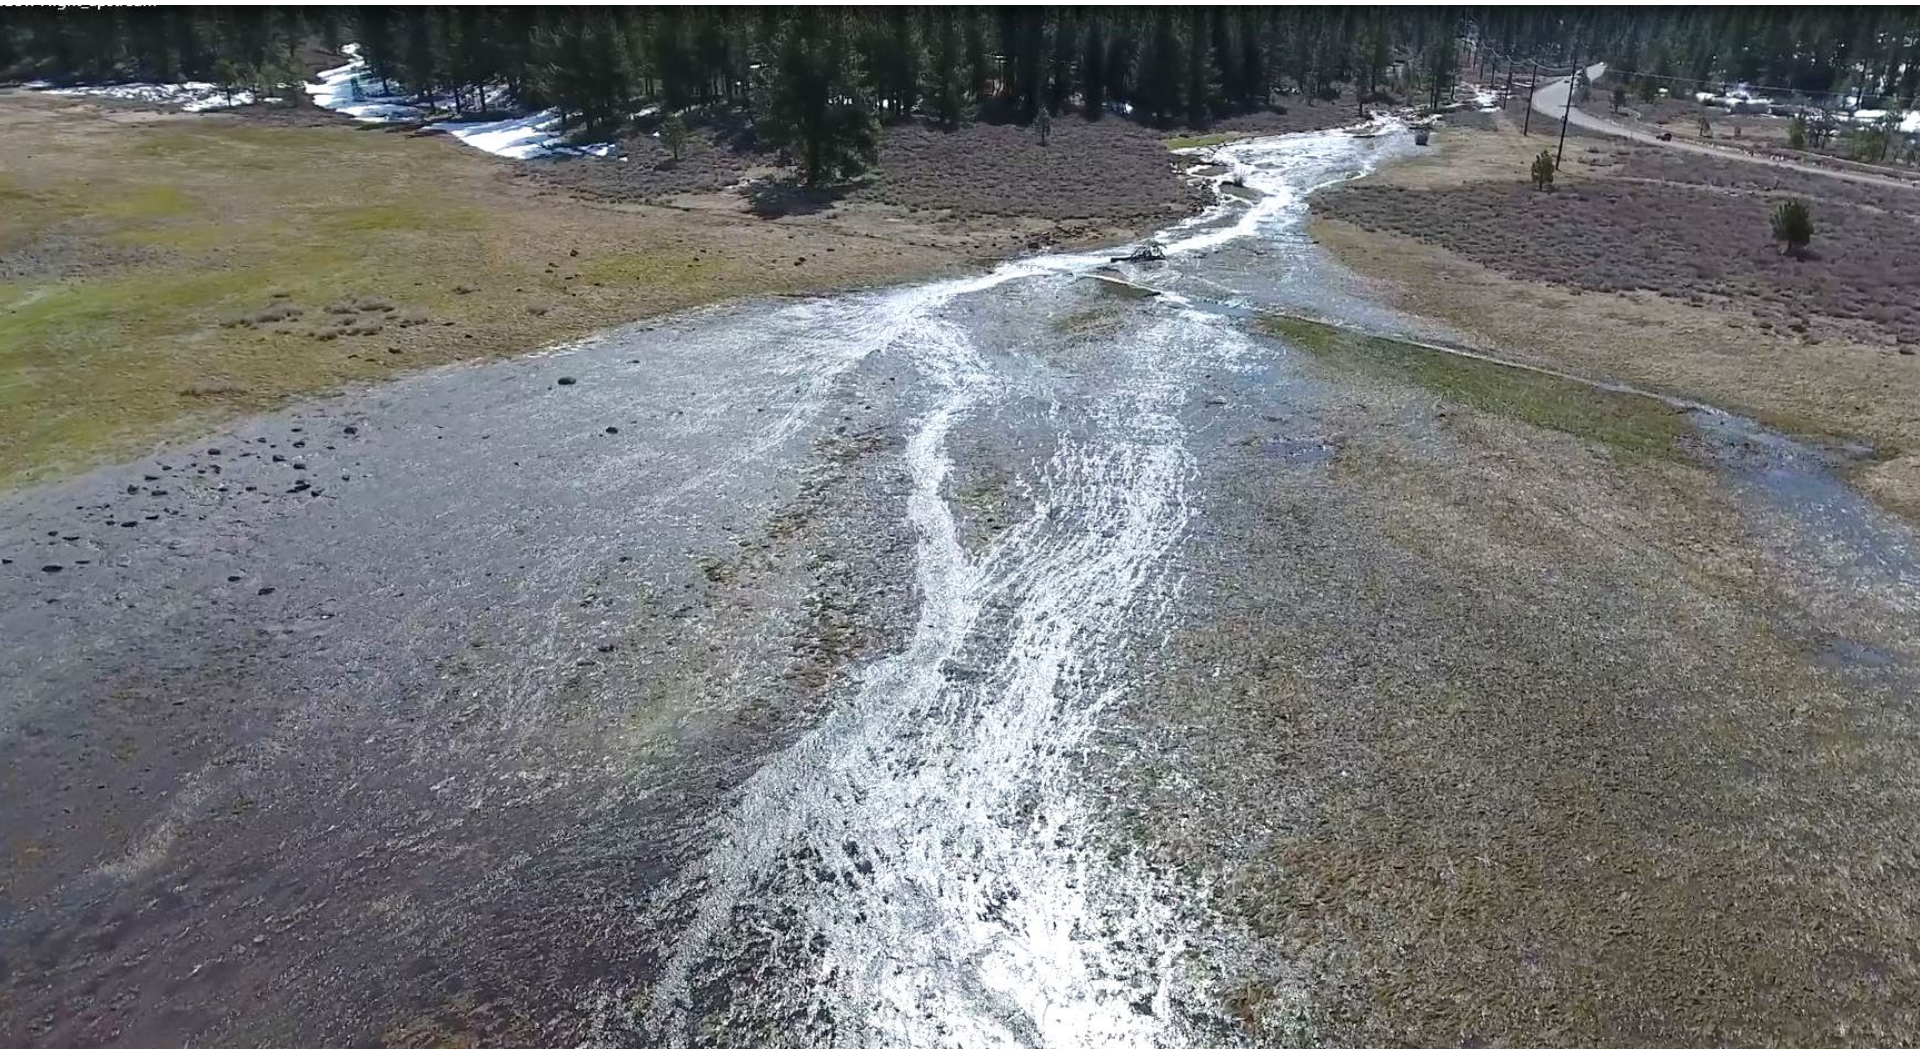
**Figure 7. Restored alluvial fan flooding, Middle Martis Wetland Restoration Project, Placer County, California.** Looking upstream toward SR 267; near peak-snowmelt runoff, April 17, 2017; flow in photo is calculated to be 25 cfs based on gaging records.

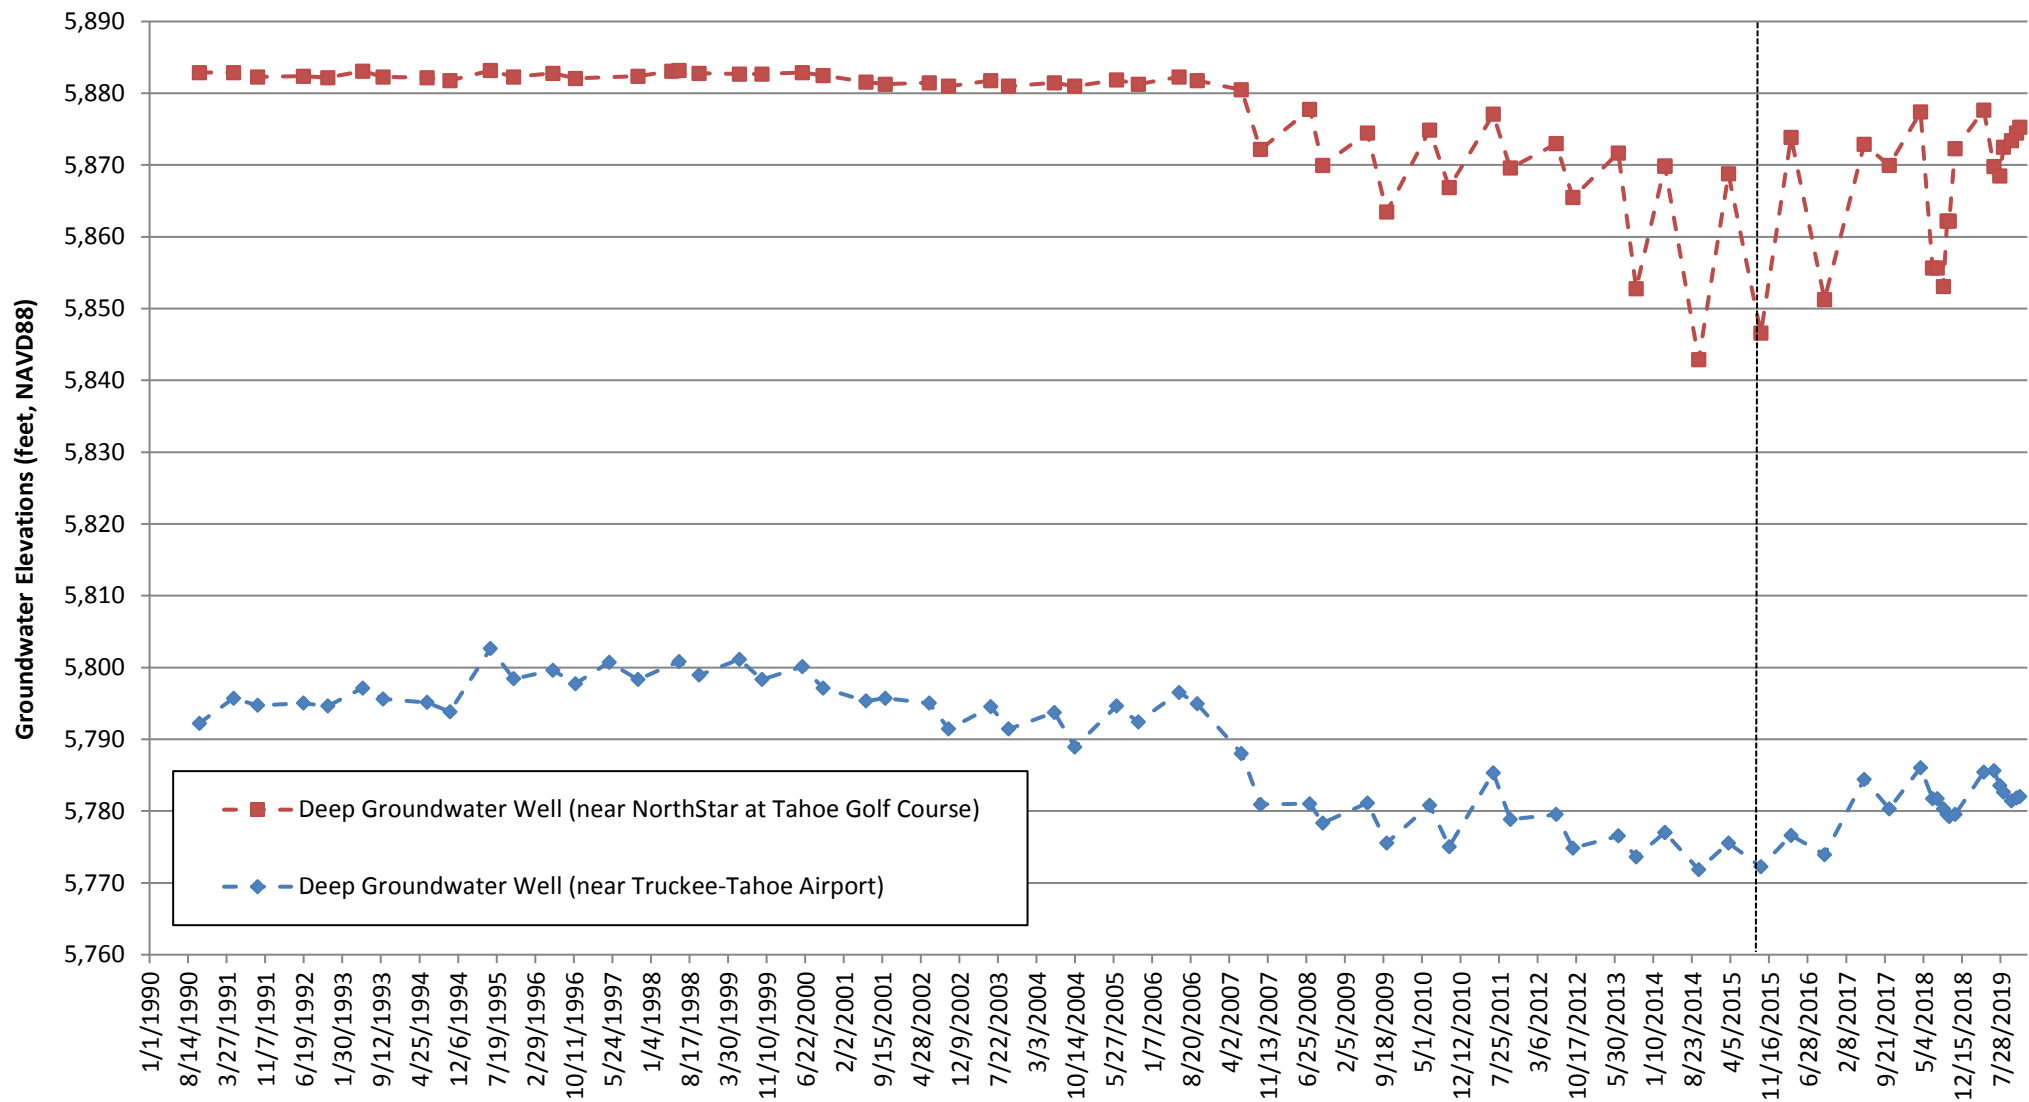
**Figure 8. Semi-annual deep groundwater elevations, Martis Valley, Placer County, California, January 1980 through November 2019.** Middle Martis Wetland Restoratoin Project was completed early November 2016 (vertical dashed line).

California Department of Water Resources (DWR) conducts bi-annual monitoring of deeper groundwater conditions from two deep wells in Martis Valley. For context of regional climate conditions and changes through the monitoring period, we show data for the period of record for these wells in **Figure 8**. From **Figure 8**, conditions between 2007 and 2015 reflect a net decline in deeper groundwater levels in the Martis Groundwater Basin with a maximum depth to groundwater recorded in October 2014. From 2016 to 2019, four consecutive years of average or above average precipitation and runoff have resulted in increases to deeper groundwater elevations, but they continue to be below the historical long-term condition (pre-2007, see **Figure 8**).

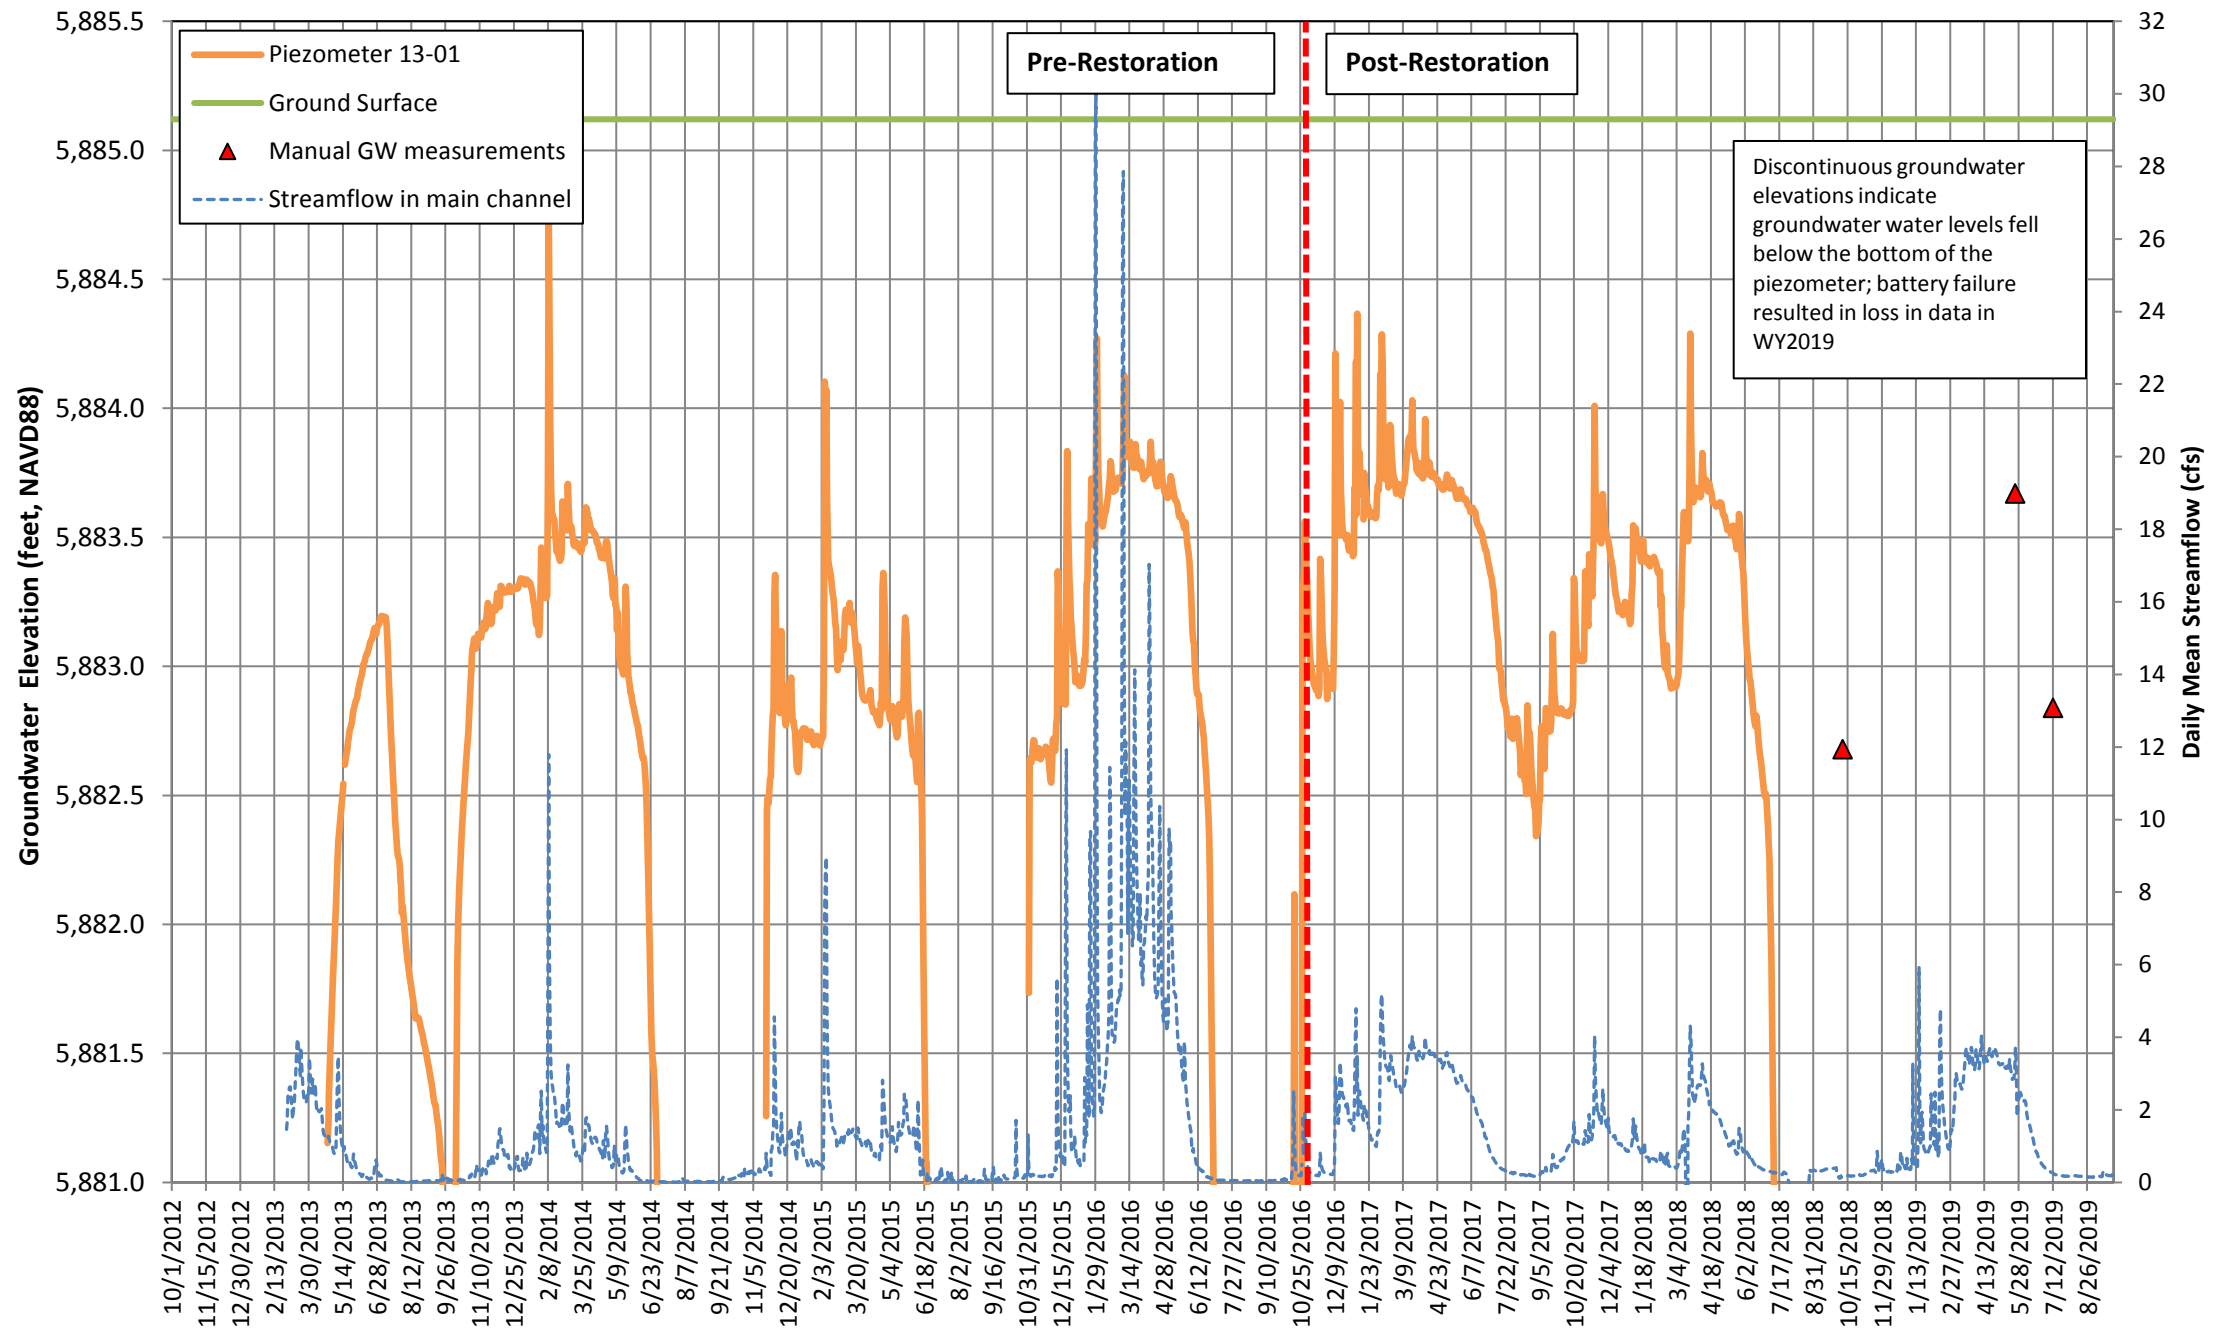
**Figure 9. Daily Shallow Groundwater Elevations in Piezometers 13-01, Middle Martis Wetland Restoration Project, Placer County, California, partial WY2013 through WY2019.** (see Figure 1 for piezometer locations)

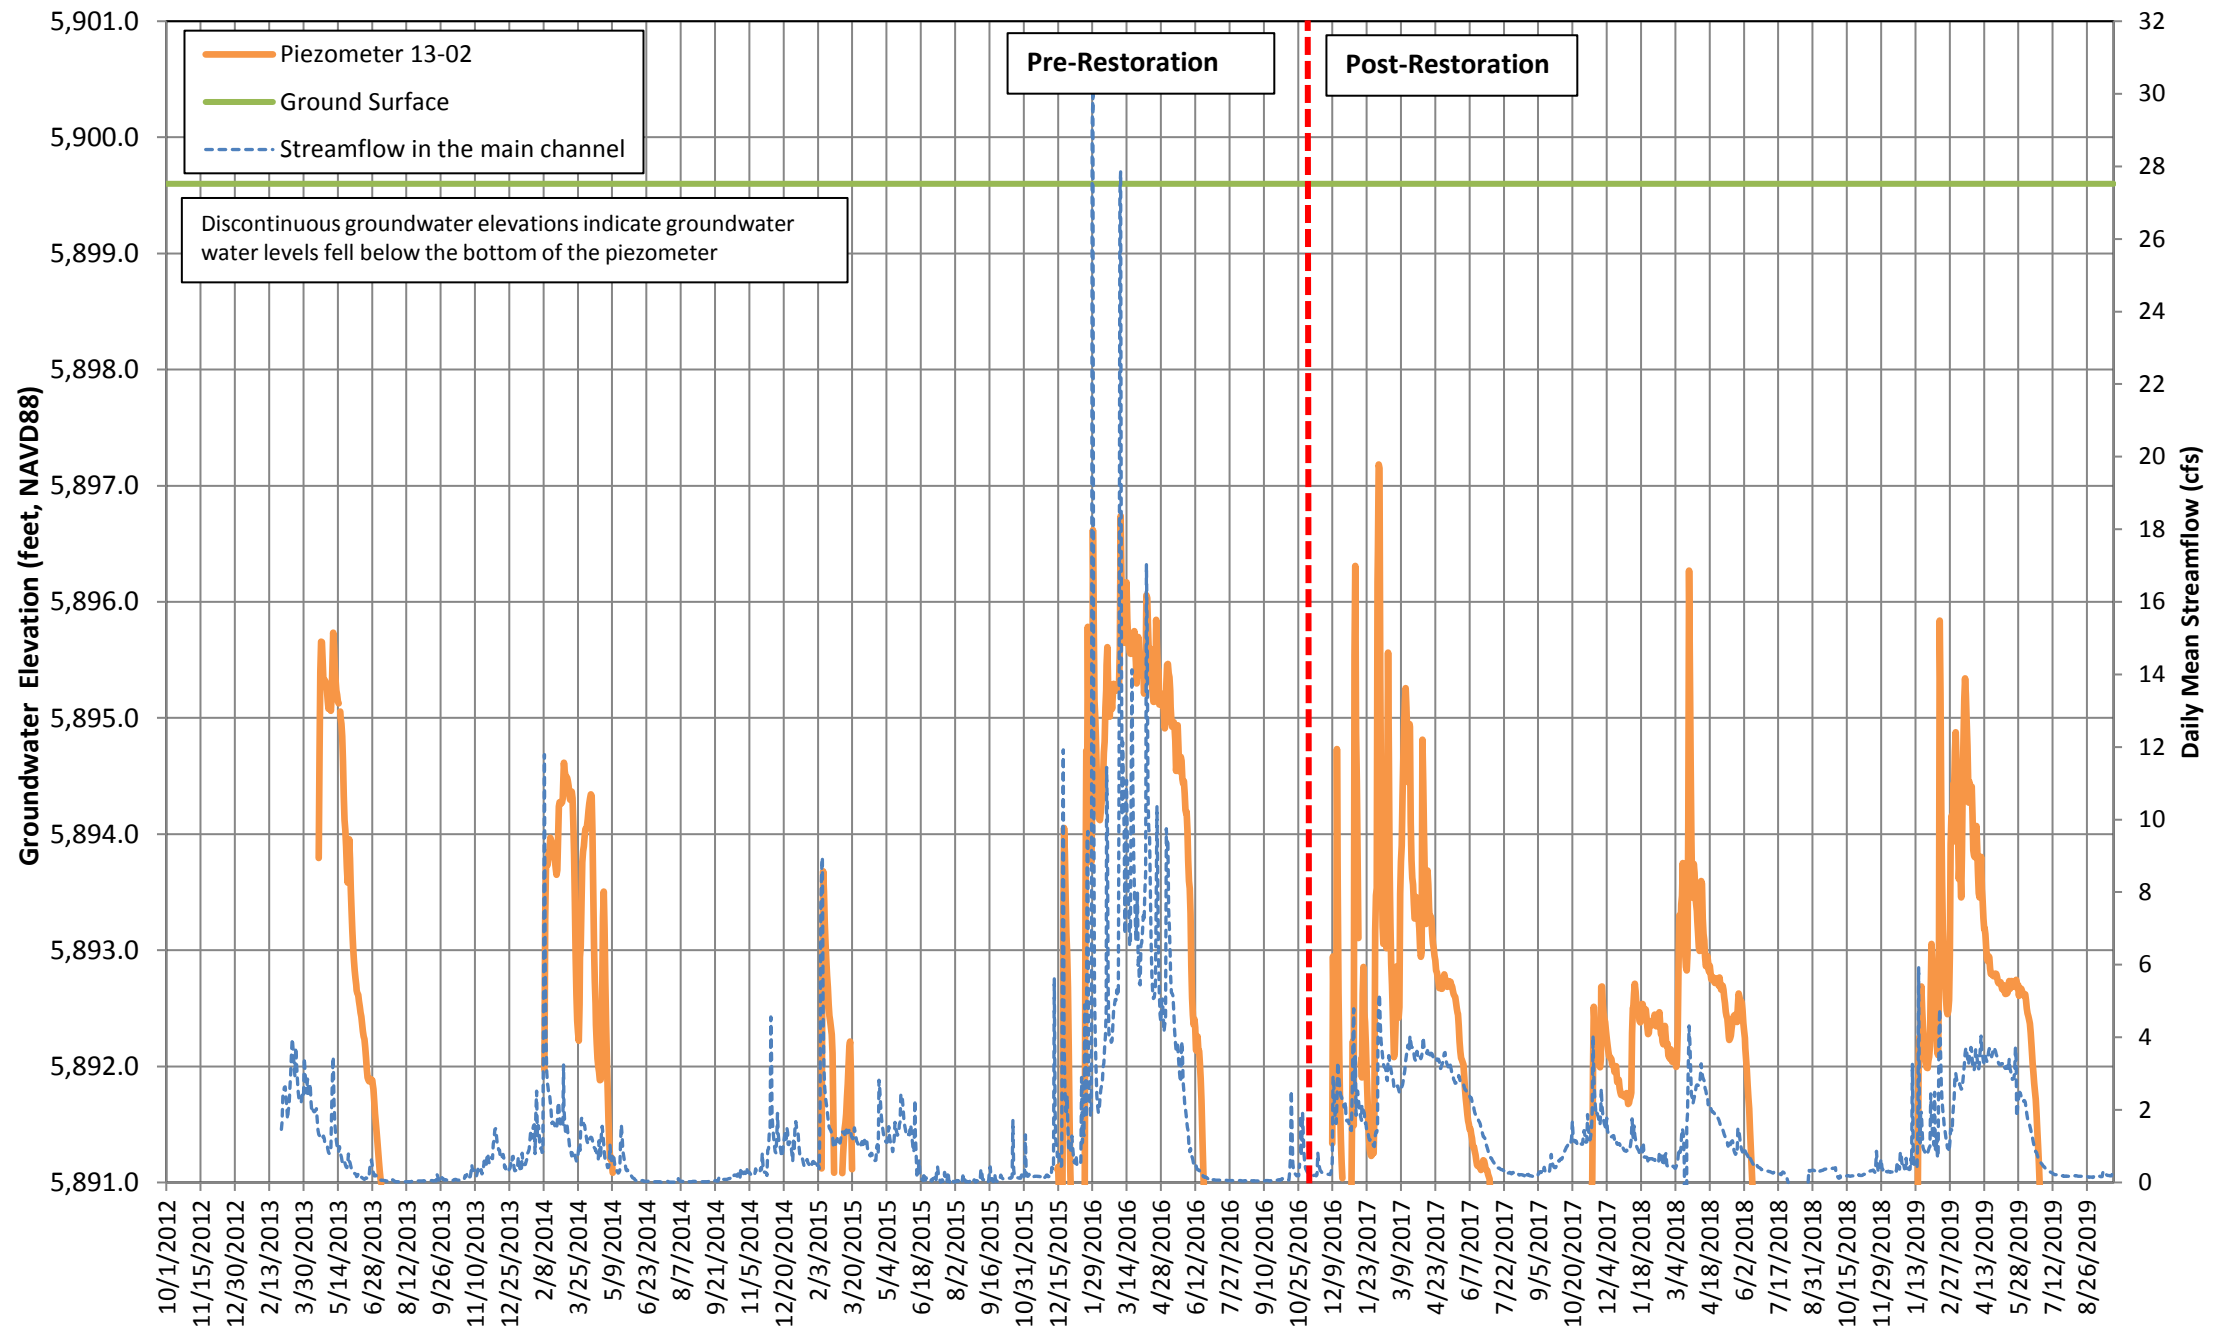
**Figure 10. Daily Shallow Groundwater Elevations in Piezometers 13-02, Middle Martis Wetland Restoration Project, Placer County, California, partial WY2013 through WY2019.** (see Figure 1 for piezometer locations)

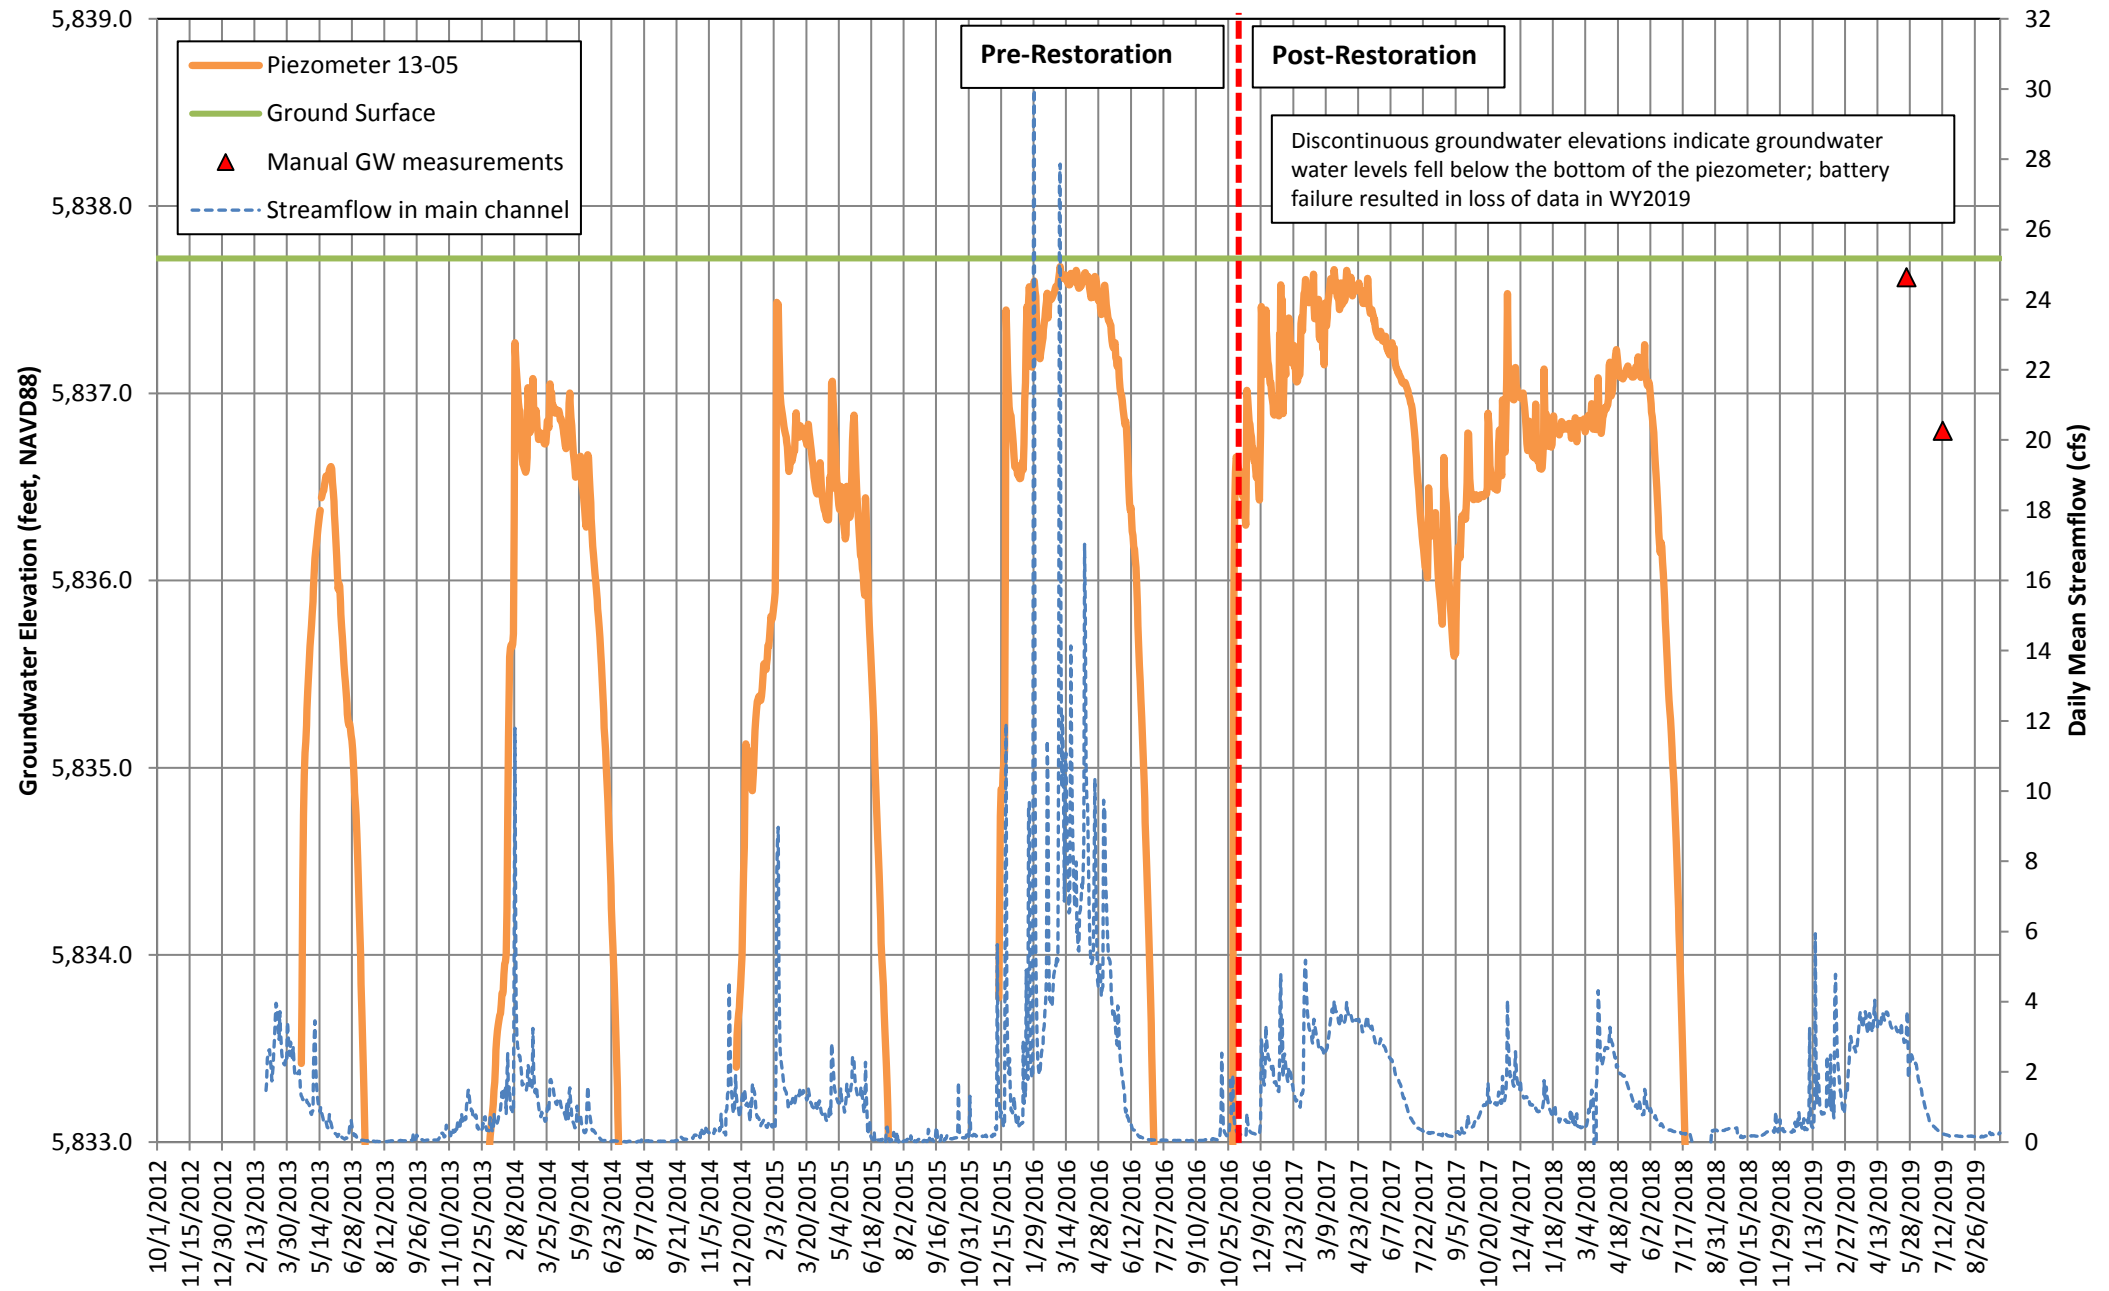
**Figure 11. Daily Shallow Groundwater Elevations, in Piezometer 13-05, Middle Martis Wetland Restoration Project, Placer County, California, partial WY2013 through WY2019. (see Figure 1 for piezometer locations).**

Piezometer 13-05 (**Figure 11**) and Piezometer 13-06 (**Figure 12**) are located further downgradient on the alluvial fan and may be influenced by surface waters from both West Martis Creek and the main channel of Middle Martis Creek. In Piezometer 13-05, groundwater elevations fluctuate more than 4.5 feet within a year and typically rise to within 12-inches of the ground surface in each year. Post-project conditions show these groundwater elevations were maintained. In fact, groundwater elevations were sustained within 2 feet of the ground surface in the first 2 years post-project, likely due to the wetter than average conditions and late season elevated baseflow observed in WY2017. Even after the project reduced streamflow in the main channel to a maximum of 6 cfs, groundwater elevations were maintained at

elevations similar to pre-project conditions. Battery failure prevented data collection in WY2019 in Piezometer 13-05; however, several manual measurements of groundwater elevations were recorded.

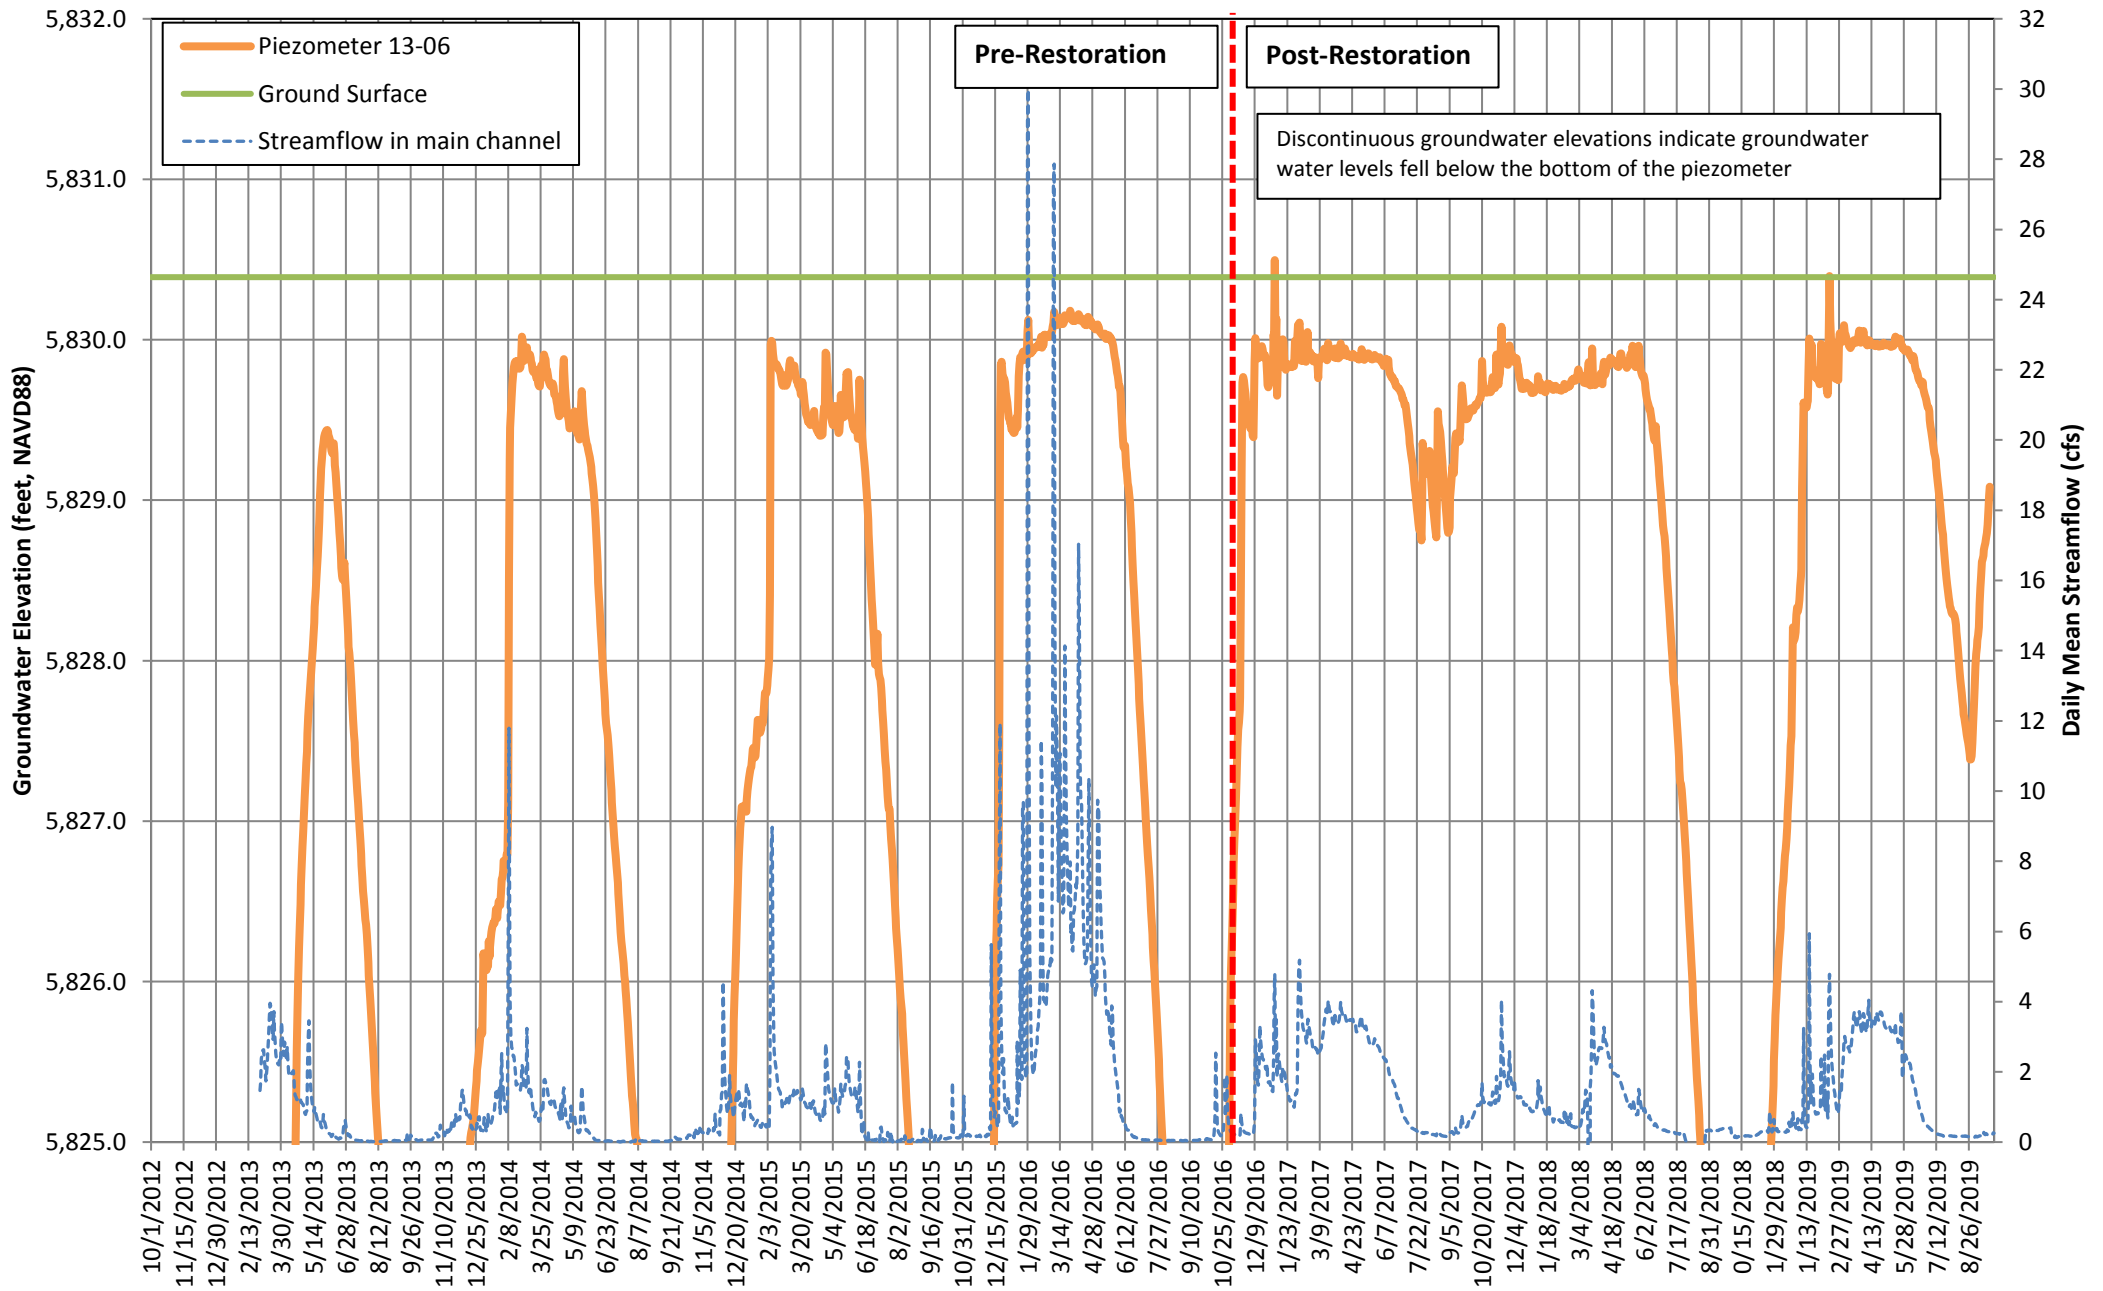
**Figure 12.**

**Daily Shallow Groundwater Elevations, in Piezometer 13-06, Middle Martis Wetland Restoration Project, Placer County, California, partial WY2013 through WY2018.** (see Figure 1 for piezometer locations).

Groundwater can fluctuate by more than 5 feet seasonally in Piezometer 13-06 and typically rises to within 12-inches of the ground surface in most years, regardless of year type. Under post-project conditions, groundwater elevations were sustained near the surface for longer durations; but these results may be indicative of wetter conditions.

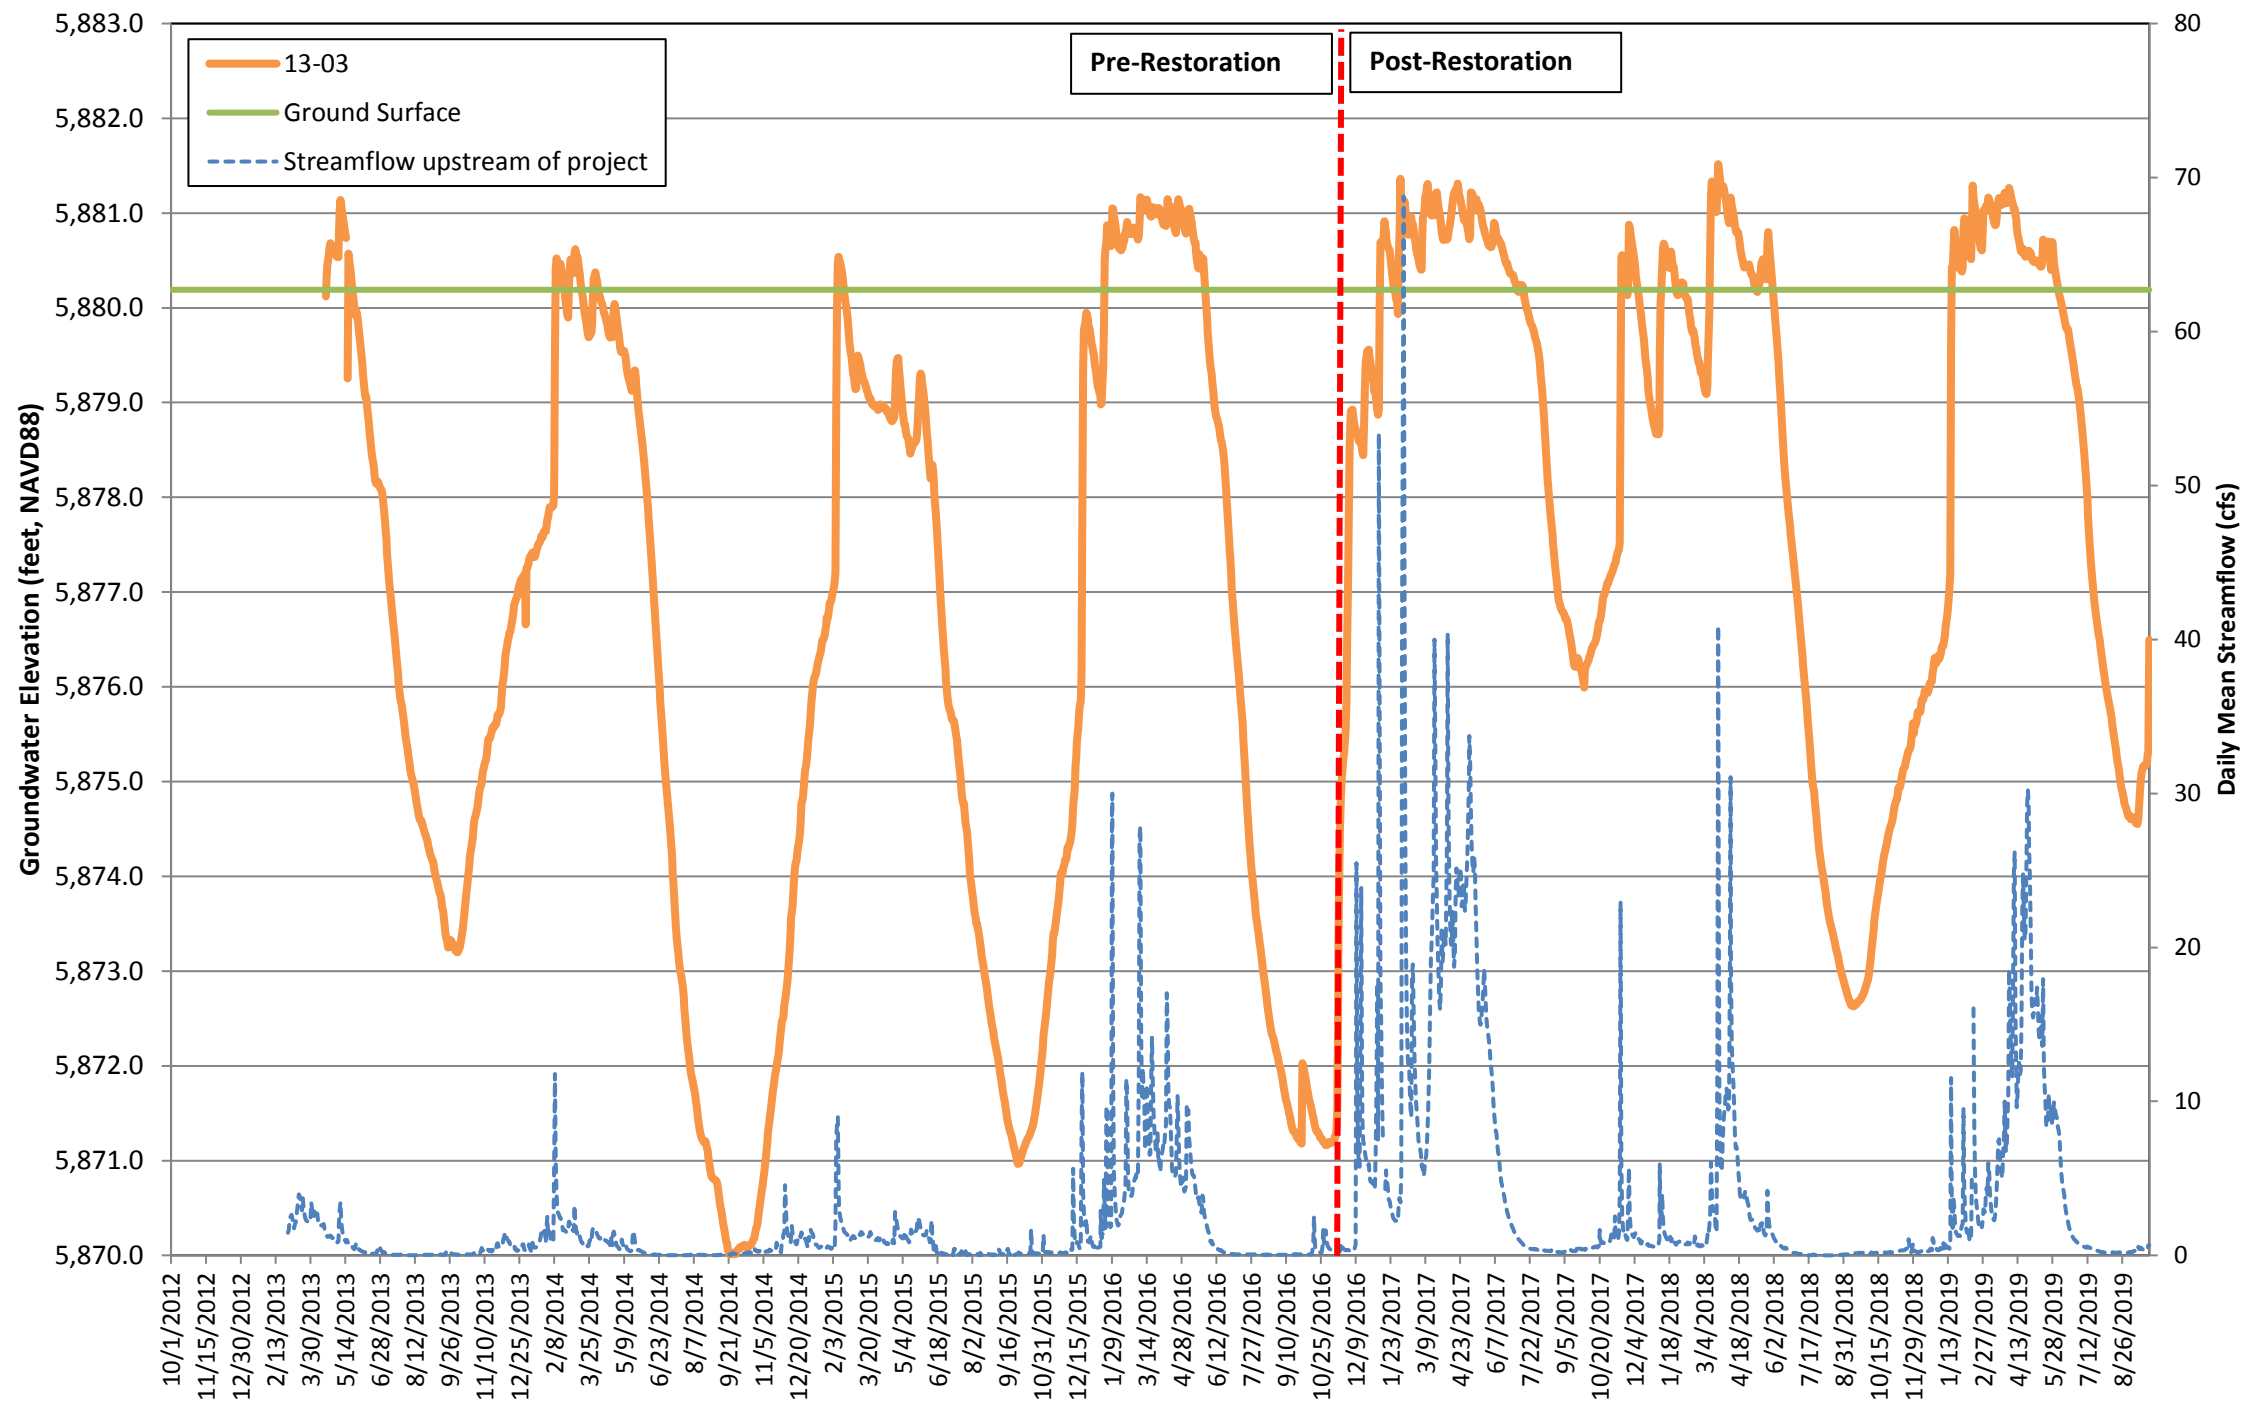
**Figure 13. Daily Shallow Groundwater Elevations, Piezometer 13-03, Middle Martis Wetland Restoration Project, Placer County, California, Partial WY2013 through WY2019. (see Figure 1 for Piezometer locations)**

Piezometers 13-03 and 13-04 are located north of SR 267 and illustrate the results of restored surface flows to the northern side of the alluvial fan. Piezometer 13-03 (**Figure 13**) exhibits seasonal artesian conditions both pre- and post-project; but groundwater elevations can fluctuate over 11.5 feet within a single year. Post project, seasonal groundwater elevation fluctuations were minimized to between approximately 5.5- and 9.0-feet post-project; likely as a result of streamflow restored to this portion of the alluvial fan.
