## Annual Report for the Martis Valley Groundwater Basin

### Water Years 2018 and 2019

# **Martis Valley Groundwater Basin Annual Report Water Years 2018 and 2019**

Truckee Donner Public Utility District (TDPUD)

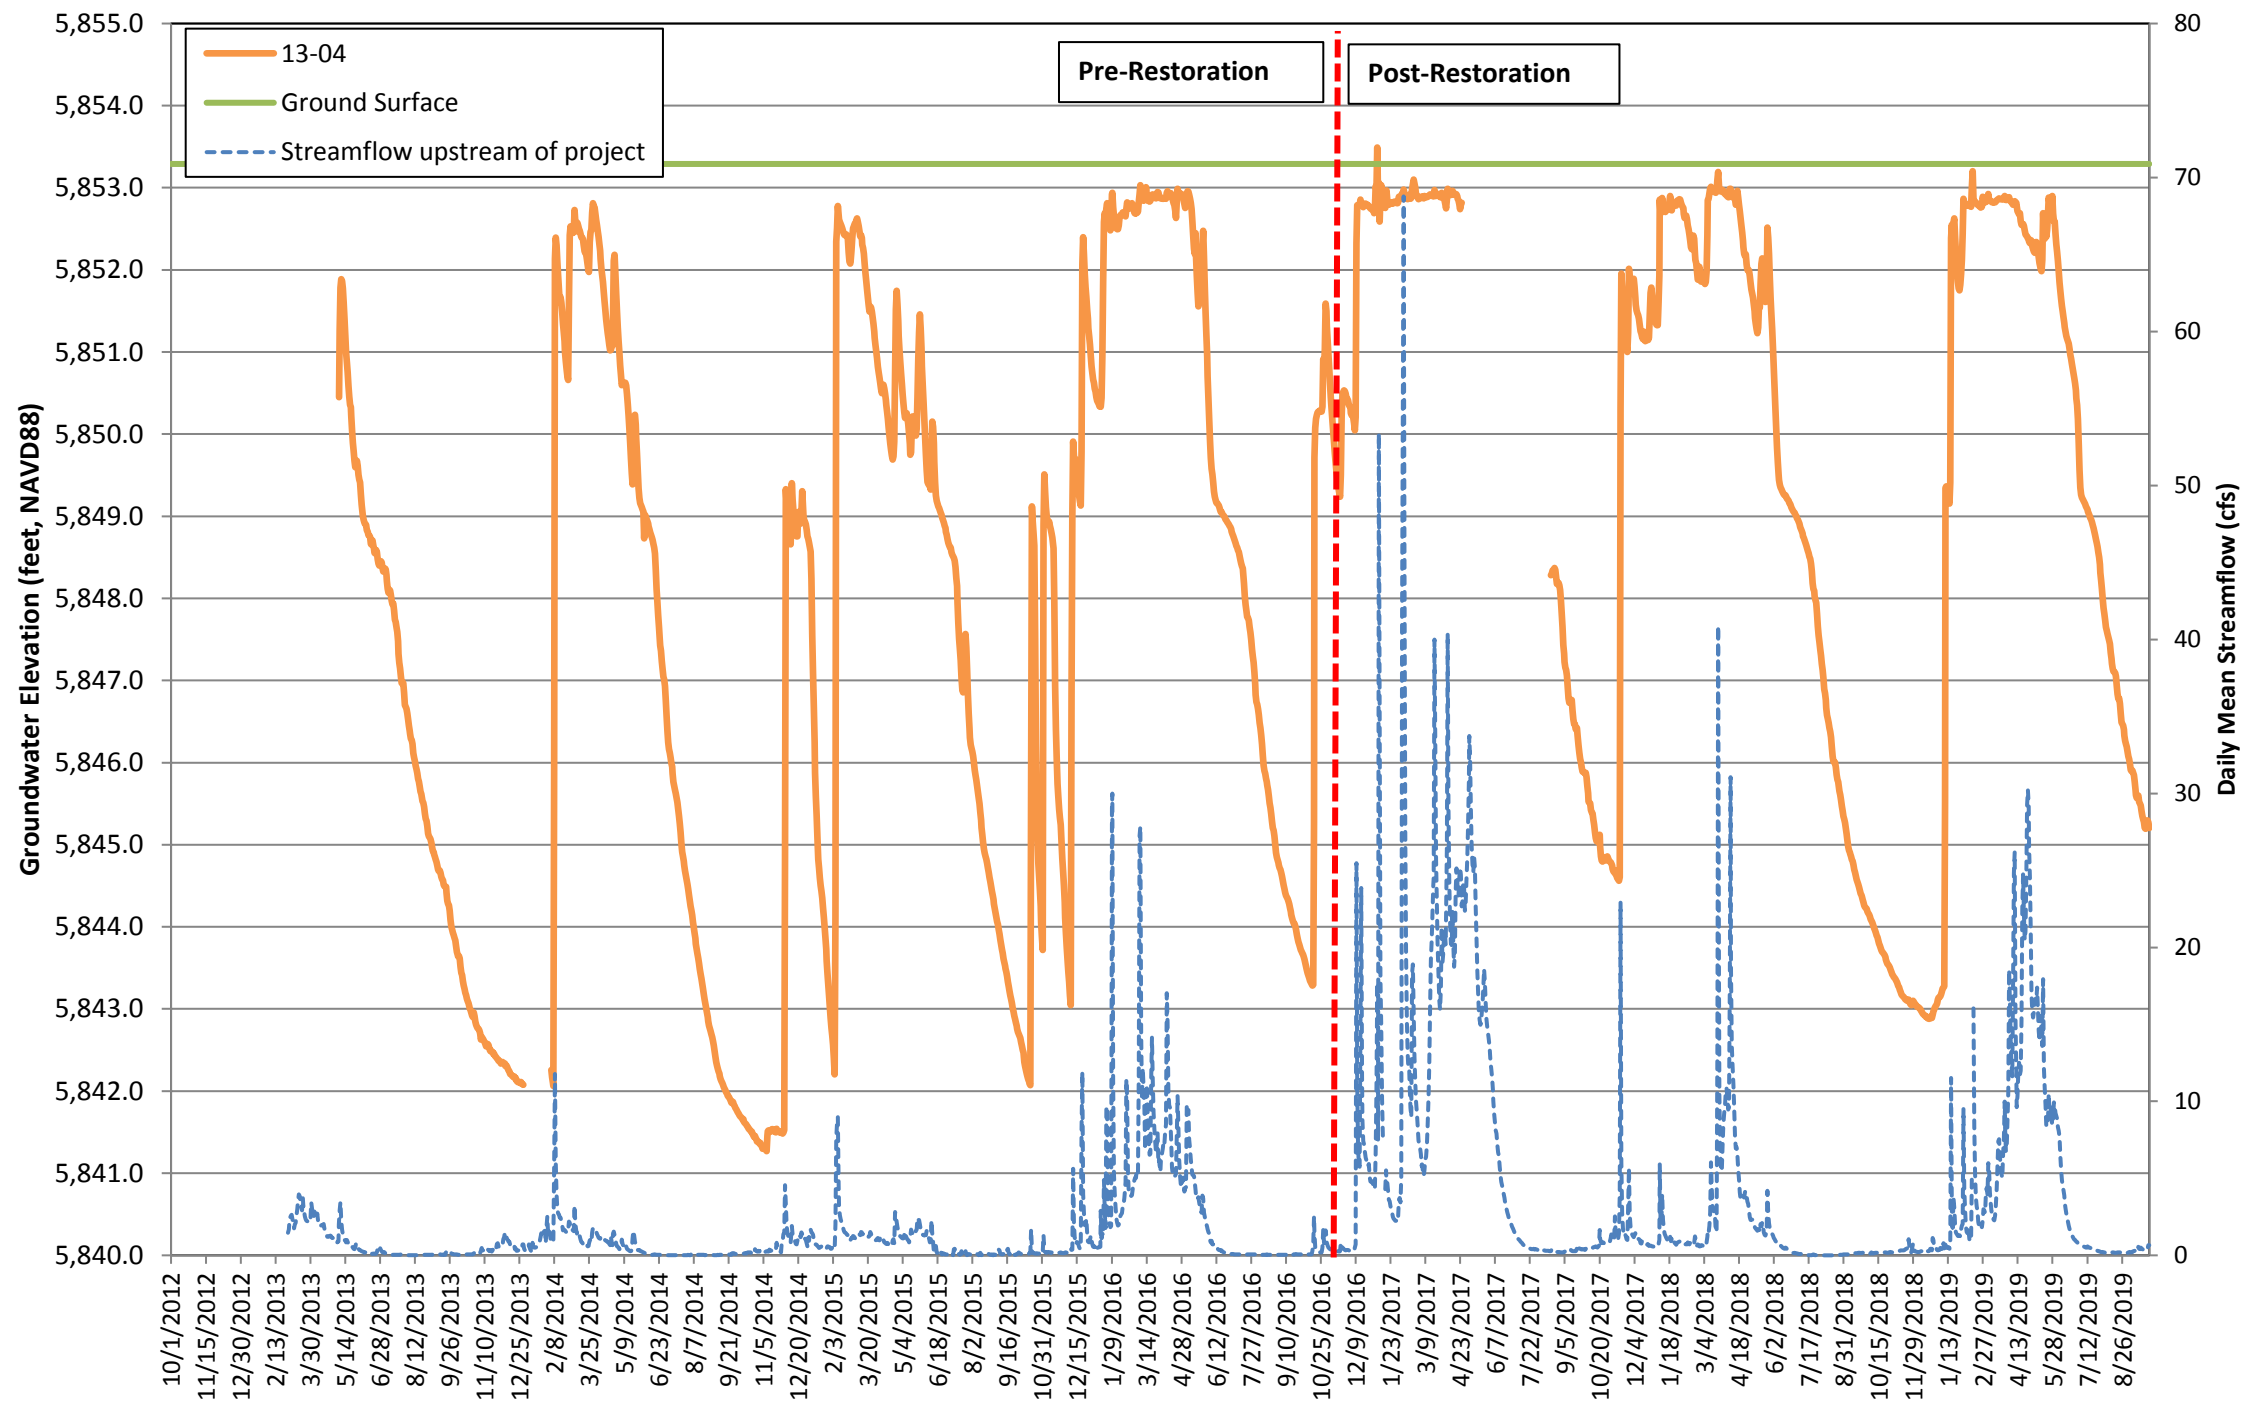
**Figure 14. Daily Shallow Groundwater Elevations, Piezometer 13-04, Middle Martis Wetland Restoration Project, Placer County, California, Partial WY2013 through WY2019. (see Figure 1 for Piezometer locations)**

Groundwater elevations measured in Piezometer 13-04 (**Figure 14**) historically fluctuated 10 to 11 feet on a seasonal basis and have risen to within 12-inches of the surface year after year, regardless of year type. Post-project conditions show that seasonal groundwater elevation fluctuations were minimized to between 8 and 10 feet and sustained elevations near the ground surface; Post-project seasonal groundwater lows at this location were very similar to pre-project lows after comparable near-average precipitation years in WY2016 and WY2018.

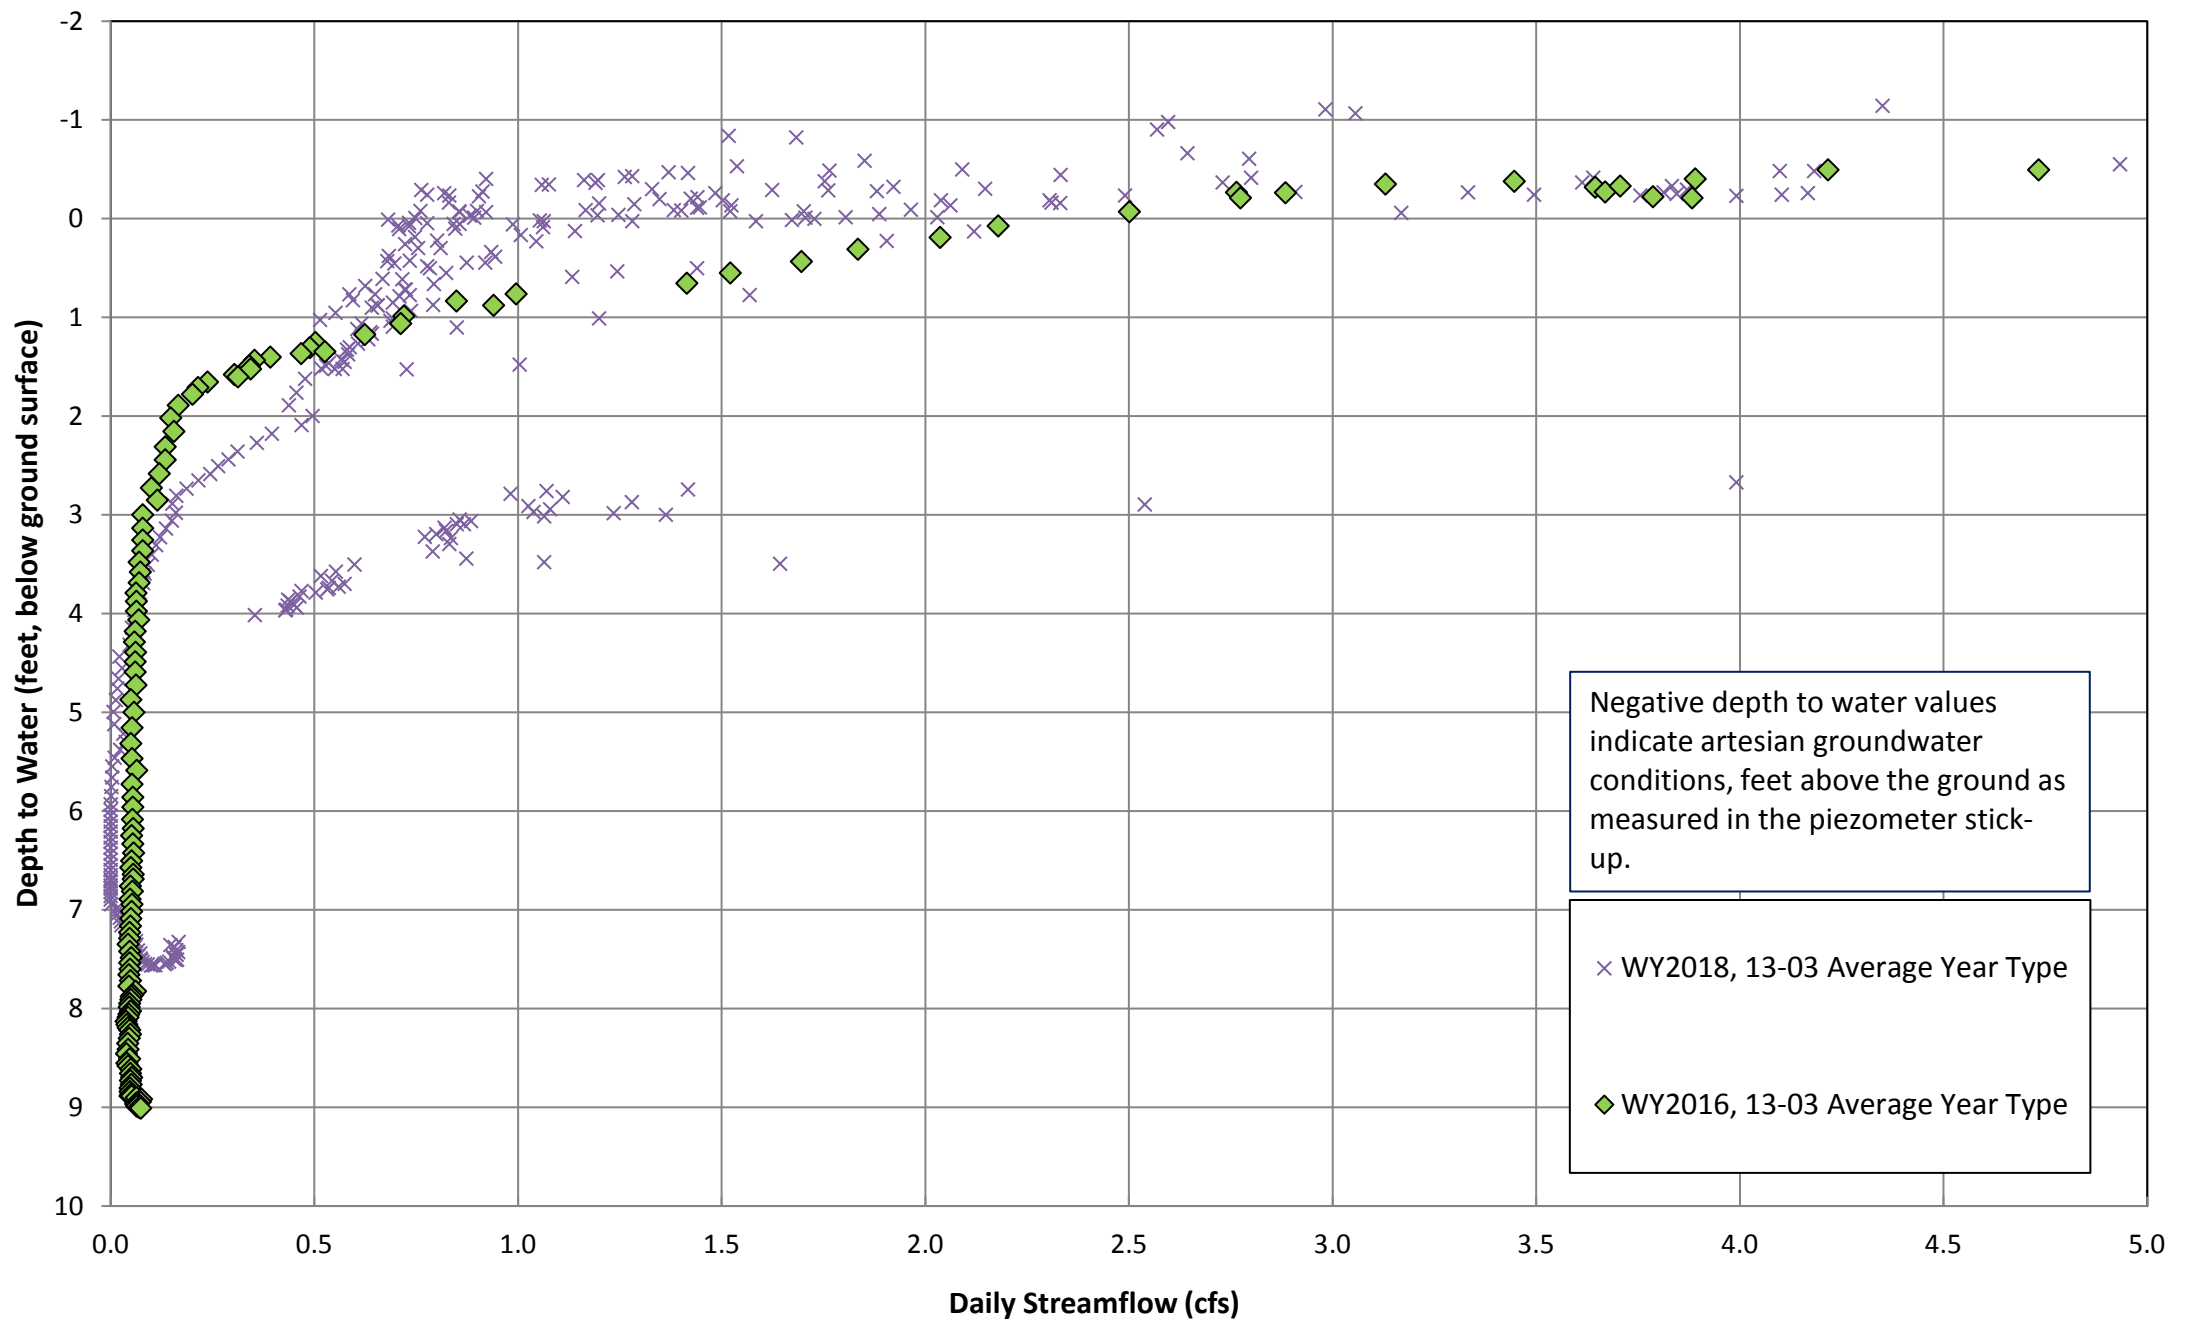
**Figure 15. Groundwater response to streamflow in the restored meadow (Piezo 13-03), Middle Martis Wetland Restoration Project, Placer County, California, WY2016 v. WY2018**  
 Post-restoration groundwater data suggests groundwater levels remained higher at lower flows when compared to pre-restoration data.

Using the data for the same two piezometers (13-03 and 13-04) daily depth to water are regressed with streamflow values measured at the gage upstream of the project for pre-project (WY2016) and post-project (WY2018), years that had similar precipitation and runoff characteristics (**Figures 15 and 16**). While variations in the data are apparent and likely related to initial storm response at the beginning of the wet season (WY2018), there are some stronger relationships that illustrate that when comparing conditions under similar hydrologic year types, groundwater is maintained near or above the surface for longer post-project when streamflow recedes below 3 cfs (as measured upstream).

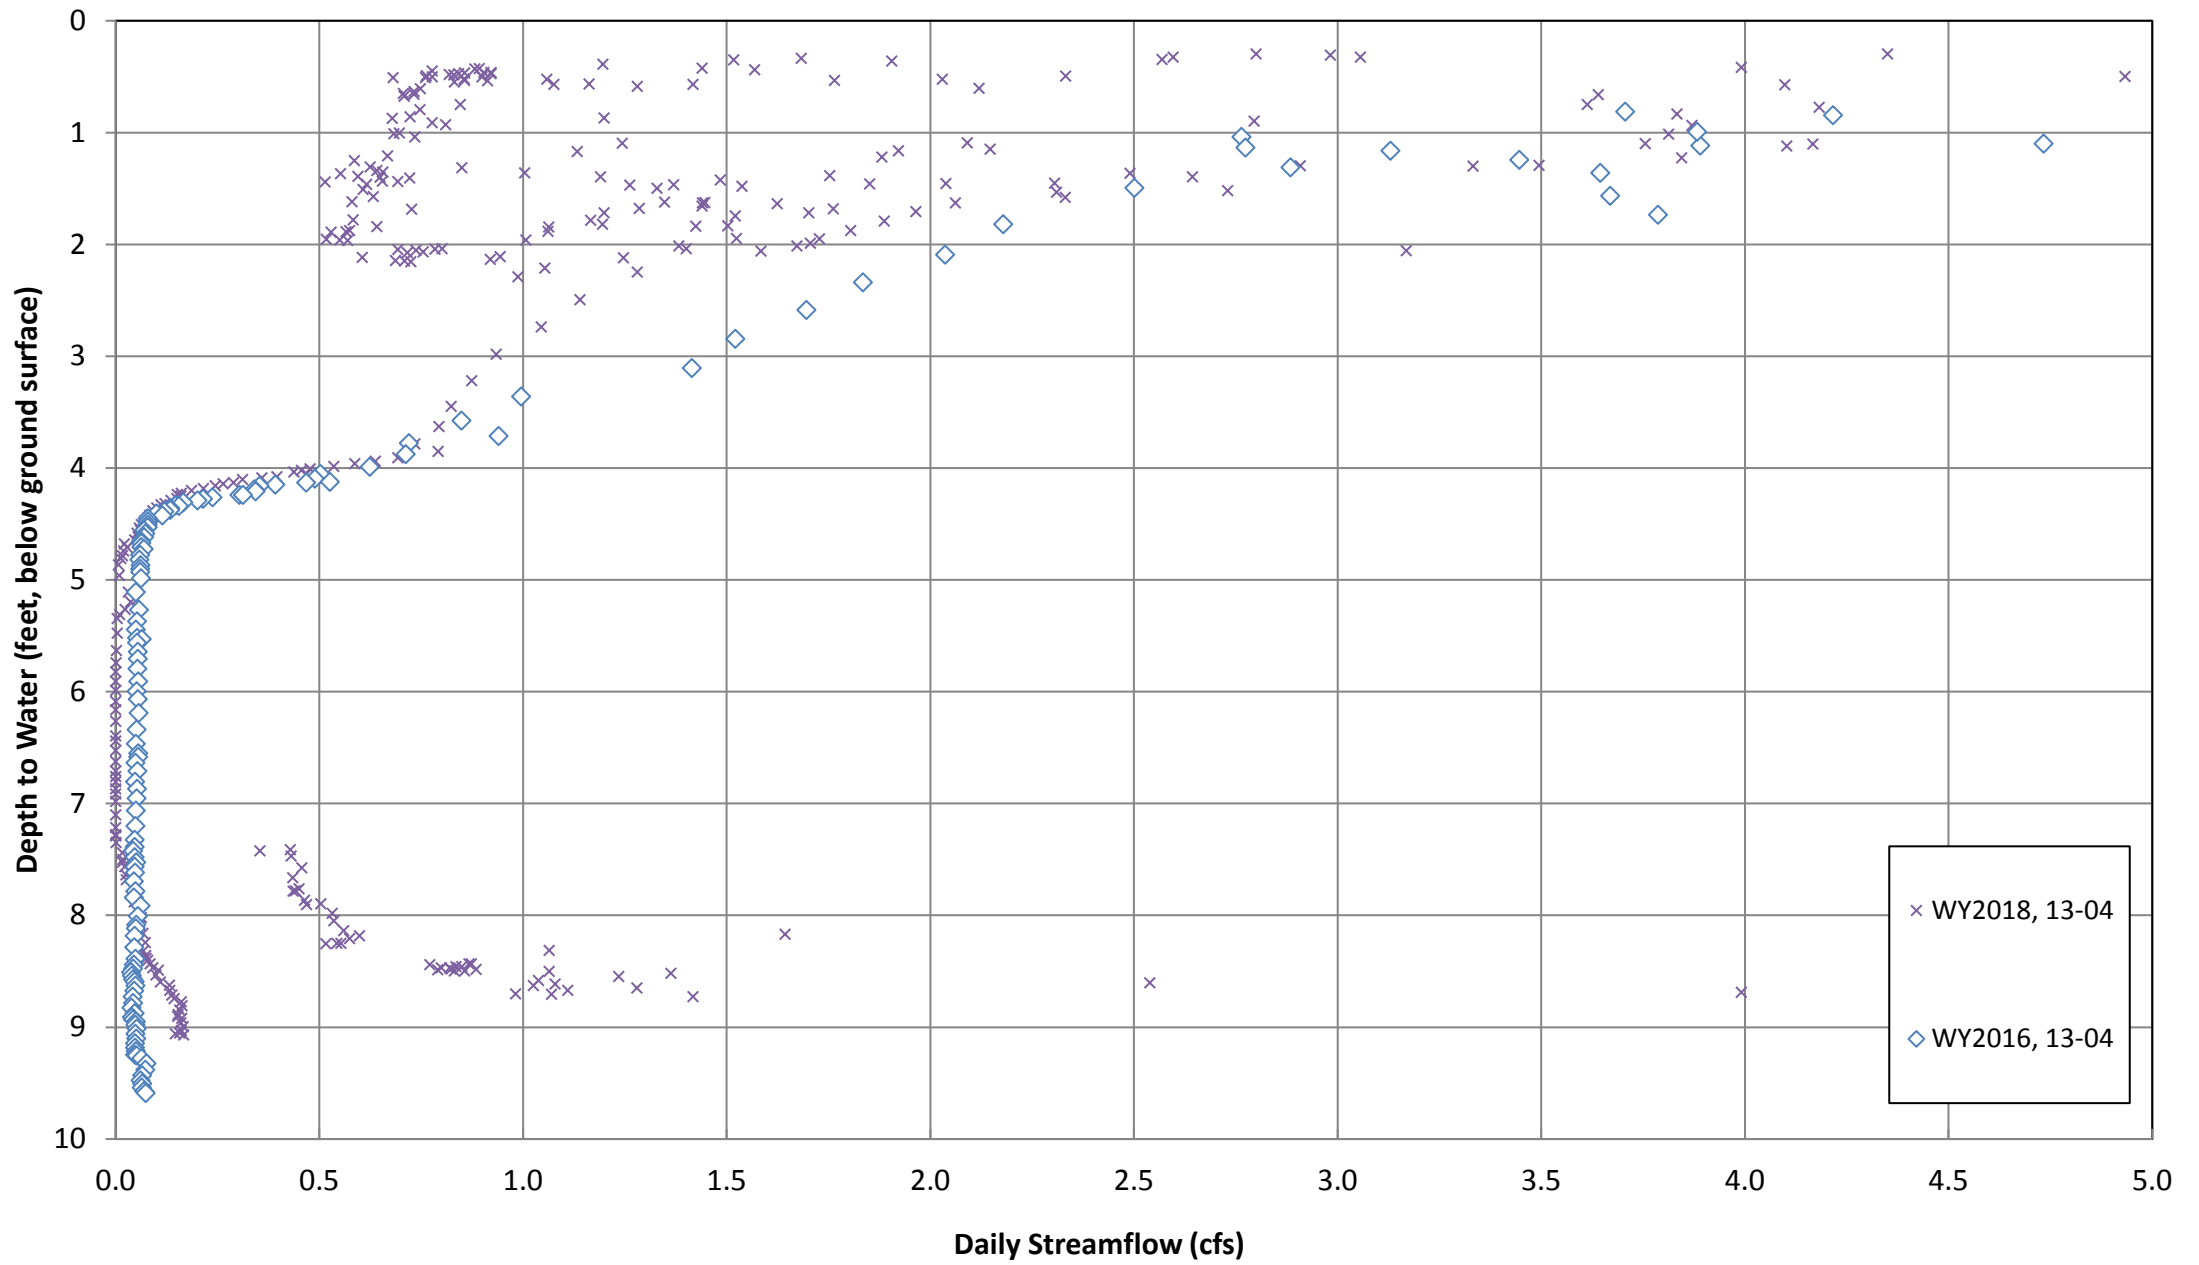
**Figure 16. Groundwater response to streamflow in a restored meadow (Piezo 13-04), Middle Martis Wetland Restoration Project, Placer County, California, WY2016 v. WY2018**
